# Analysis of PWSS at GP level and Mechkarwadi Piped Water Scheme Failure and Success Analysis (Mograj GP)

Centre for Technology Alternatives for Rural Areas IIT Bombay

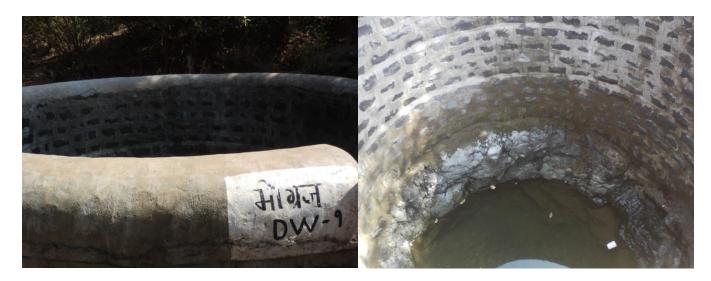
#### Mograj Dug Well-1

Well was dug many years ago however only Cementery was done- 2-3 years ago under NREGA scheme also every year mud is taken out under the same scheme. It is only 40 ft deep residents of village can get water only up to month of March.

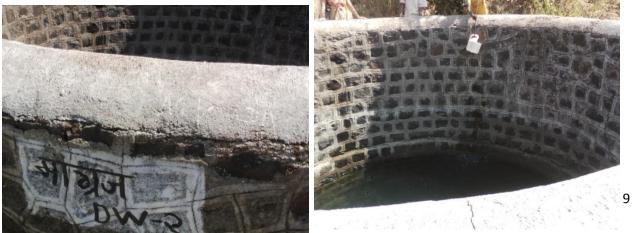
Mograj Dug Well-2

This well is about ----- m away from the village and is situated on the line of paddy fields. It is 40 m deep and diameter of 6m. Cementing was done under NREGA scheme in 2008-2009. It serves village for another 1-1.5 month after DW-1 well gets dried up.

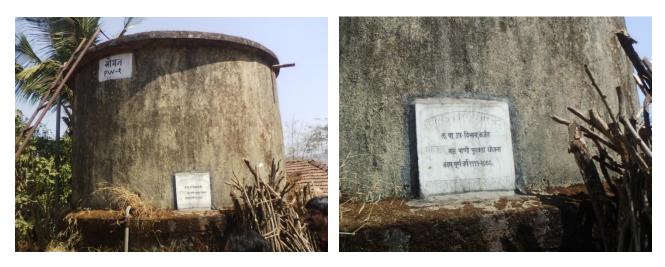
#### Mograj Pipe Water (PWSS)-1

It was a combined Mograj-Anandwadi Piped Water Supply Scheme (PWSS) implemented by Minor Irrigation (MI) department. The scheme is not working for last 11 years in this village.

- 1) Source was insufficient for the two villages (Anandwadi and Mograj)
- 2) Pipe Stolen and Pump was burnt.

Due to insufficient water in the well; water pump was burnt afterwards water supply stopped and eventually pipe connecting source well and tank in the mograj village was stolen.

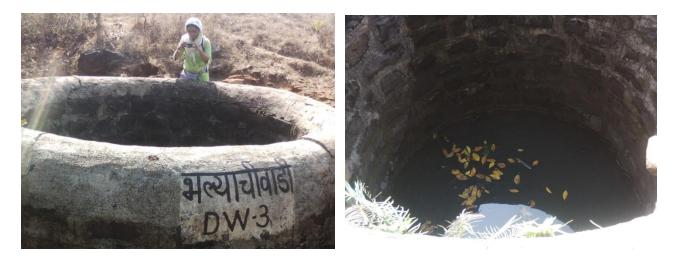
There is only one well in the wadi which is the only drinking water source. When it dries up villagers dig river bed up to 2-3 ft and get muddy drinking water.

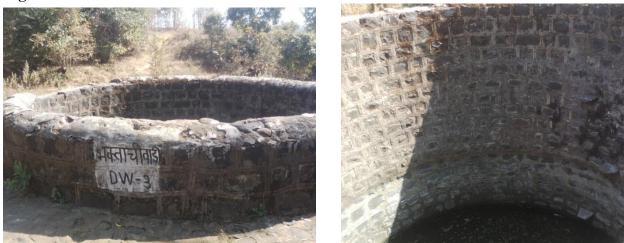
Dug Well-3

This well is near river bed and contains sufficient water for the entire village for whole year but 3-4 years ago some lady committed suicide in this well so villagers are reluctant to use its water.

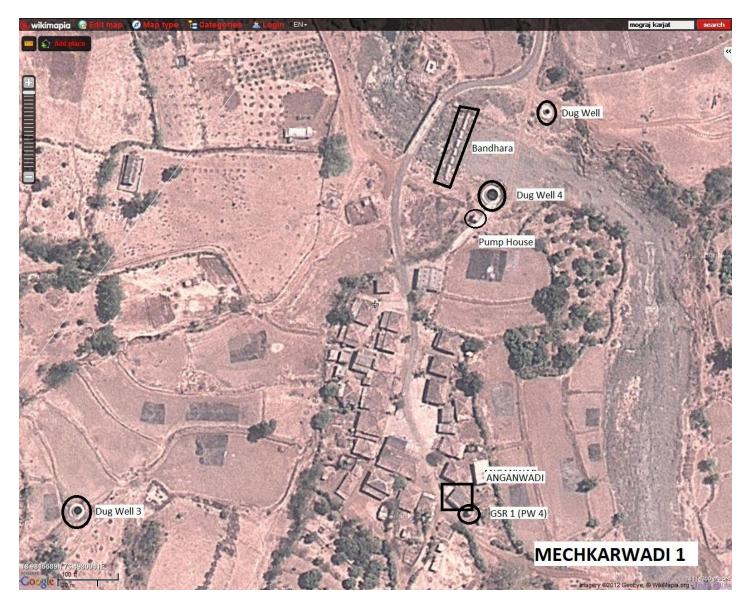
#### MAP of Mechkarwadi 1

This part (Part-1) of the Mechkarwadi is currently running a PWSS scheme which is completely handled by villagers. Dug Well-4 (DW-4) is source well for PWSS. Dug well 3 is used by 3-4 houses which are nearby that well. All other houses in the wadi use water from PWSS. Ground Service Reservoir-1 (GSR-1) of 10000L capacity is located near anganwadi.

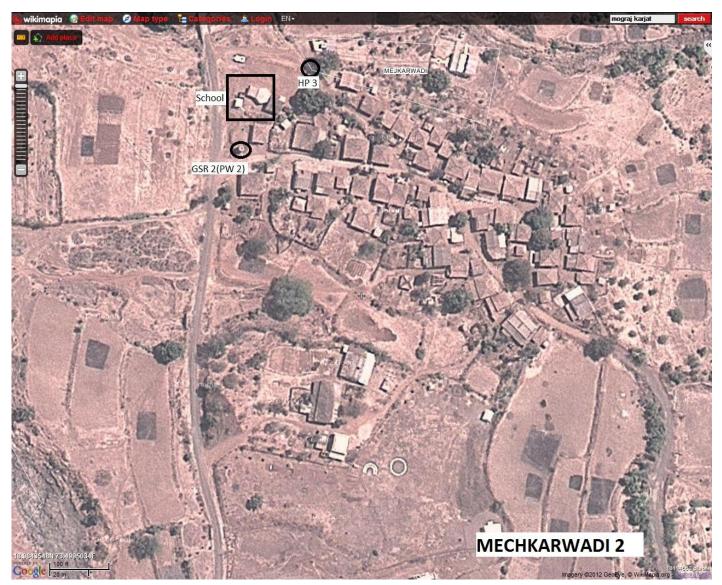
#### MAP of Mechkarwadi 2

Mechkarwadi-2 has 45 houses. They use Hand Pump 3 to satisfy their water needs. After diwali whole wadi cannot get water from hand pump they go to Dug well and Dug well 4 for water.

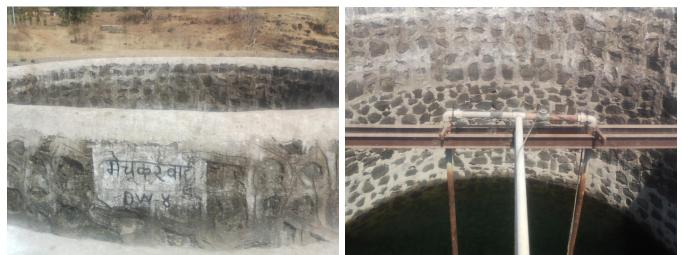
# Dugwell 4

Dug Well-4 is the source well for PWSS. It was built as a part of scheme in 2004. It is 30 ft deep. This well is also used by people of Mechakarwadi-2 after their hand pump is not sufficient for all. Diameter is 6 meters. Water in the well is present for all 12 months which is only sufficient for drinking purpose.

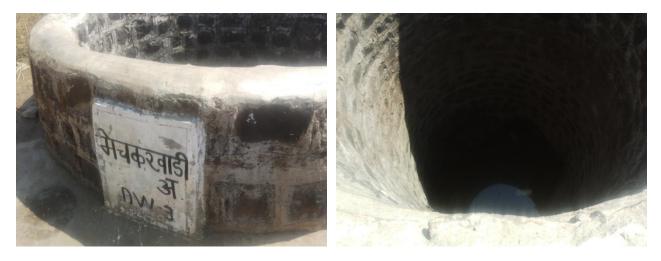
#### Dugwell 3

It is used by 3-4 households which are away from the main wadi. This is sufficient for them for the whole year. It is 30 ft deep. It was built in 2008-2009. Used only for drinking purpose.

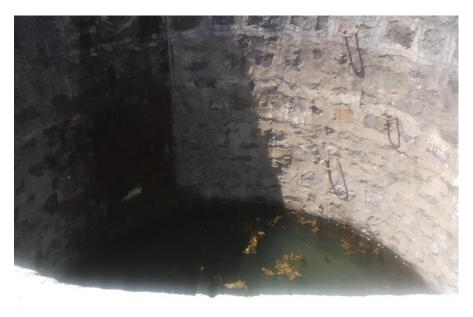
#### Dugwell (Not numbered)

It is used by 4-5 households from wadi 2 which are near to it. This is not sufficient for them for all the 12 months. It is 30 ft deep. Used only for drinking purpose.

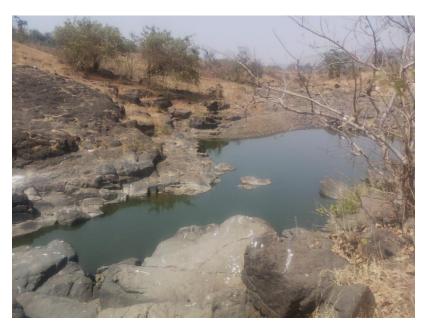
#### <u>River</u>

River water is used for all other purposes than drinking. In the river bank where there are natural water stoppages, water is stored in it and used for the whole year.
