Watershed Interventions for Kurlod and Botoshi

Phase I

December 2014

Technology and Development Solutions Cell (TDSC)
Centre for Technology Alternatives for Rural Areas (CTARA)
Indian Institute of Technology, Bombay (IITB)

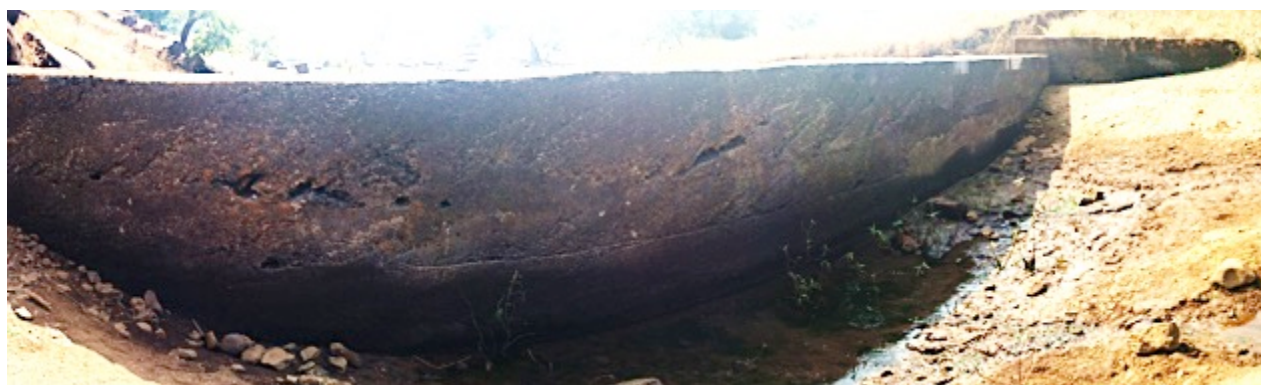
Figure 4 - Photo of the existing bund (upstream) near Kurlod, water is leaking from the base.

Current status: Kurlod's existing bund stands on a stream that flows into the Pinjal River. The bund has a significant leakage problem; by the end of November virtually all the water stored leaks out. Large cavities and cracks can be seen at the base and in the body of the bund.

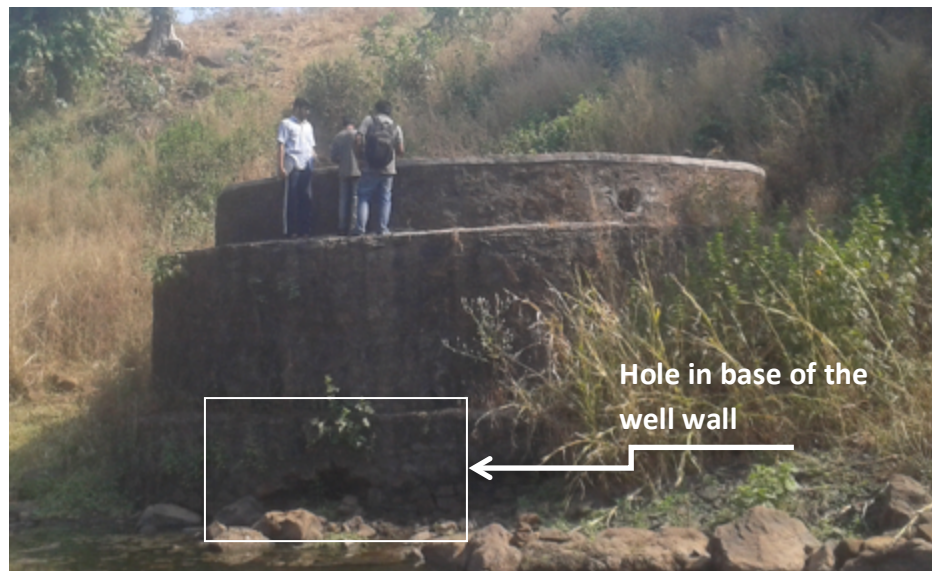
Figure 7 - Photo of Pethechapada's Well 3 showing hole at base of platform.

Current Status: Pethechapada's Well 1 lasts through the year but is not used because the well water has too much silt. There is a large hole at the base of the wall, through which muddy water may be entering during the monsoons. The well is also difficult to access.

Intervention details: TDSC proposes plugging the hole in the well to prevent muddy surface water from entering it during the monsoons, de-silting of the well, and constructing a concrete pathway to the well.

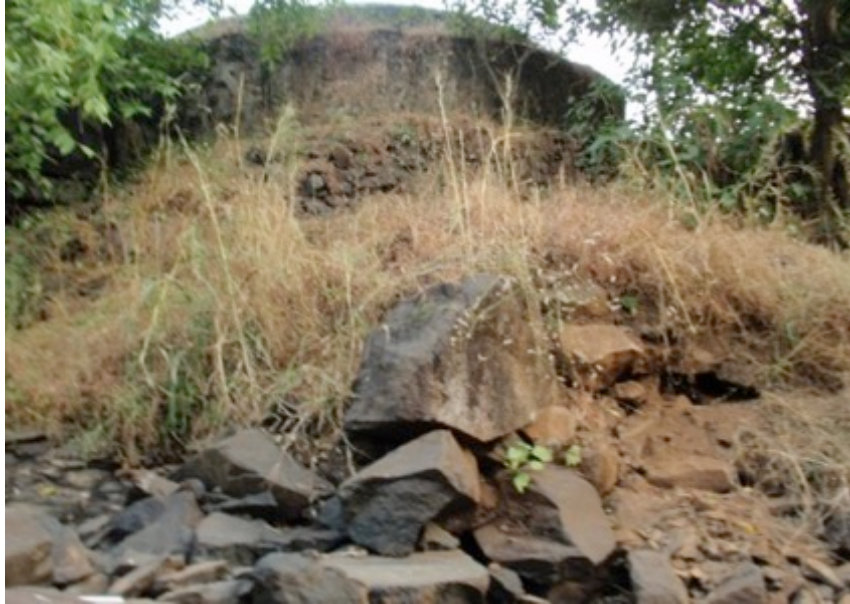
Figure 8 - Photo of Pethechapada's Well 3 from the stream that recharges it (downstream).

Current status: Well 3 lies along a minor stream that recharges both Well 2 and Well 3. Well 3 runs dry in December, but villagers report that the stream flows through the year, which can be explained by the steep gradient of the stream. The stream's elevation drops steadily as it flows past Well 3, such that the stream is almost 3 m below Well 3 just a short distance downstream of it, which limits recharge to the well after the monsoons.

Phase II planned intervention: In Phase II, TDSC proposes a new bund approximately 35 m downstream of Well 3, which will be at least 3 m in height above ground. At an FSL of 3 m, the water stored in the bund will be able to recharge Well 3 so that it lasts beyond December and also for irrigation.

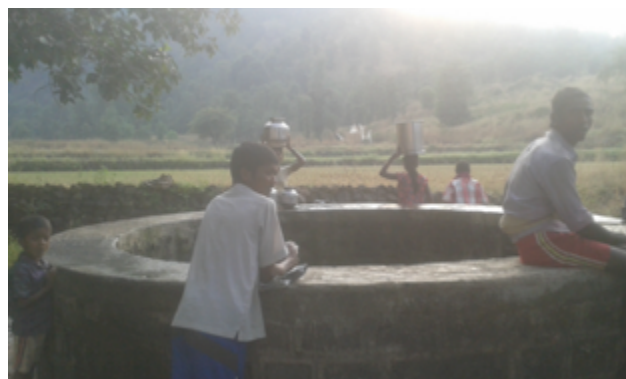
Current status: Shedyachapada and Jambhulpada have a well that lasts through the year that is accessible to both habitations; the only problem is presence of bacteria and debris in the well due to leaves and bird droppings.

Figure 10 - Photo of primary well of Shedyachapada and Jambhulpada.

Intervention details: There is just one intervention planned for Shedyachapada and Jambhulpada: the placement of a protective net over the well. Inexpensive well covering nets are available in the market and are straightforward to install.

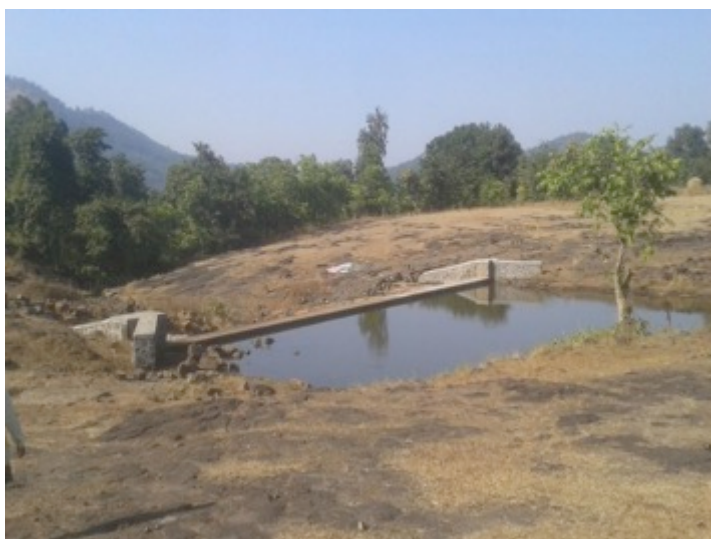
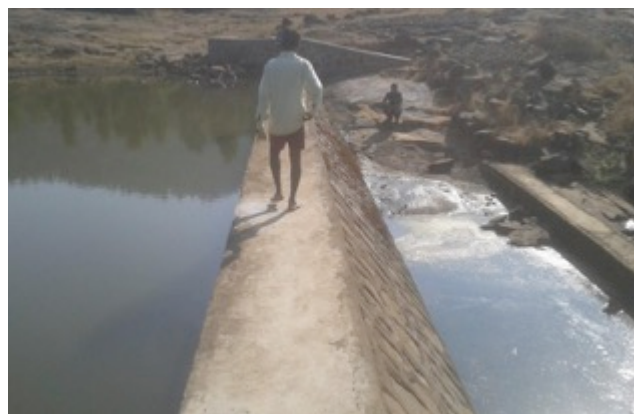
Figure 12 - Photos of Raipada’s Bund 1.

Current status: Raipada’s existing bund (see photos below) holds water until February, and was built with the intention of providing water for irrigation. Physical details about the bund are in the table below. The bund has minor leaks in a few places: if they are repaired the bund would retain water beyond February, and a pumping system can be installed in the future to pump water to the fields for a second crop.

Intervention details: TDSC proposes plugging the minor leaks in the bund during Phase I so that the bund can store water beyond February and reliably support a second crop. The fields around the bund are approximately 1 m higher in elevation, so a temporary pumping system could be installed to transport water relatively inexpensively to the nearby fields.

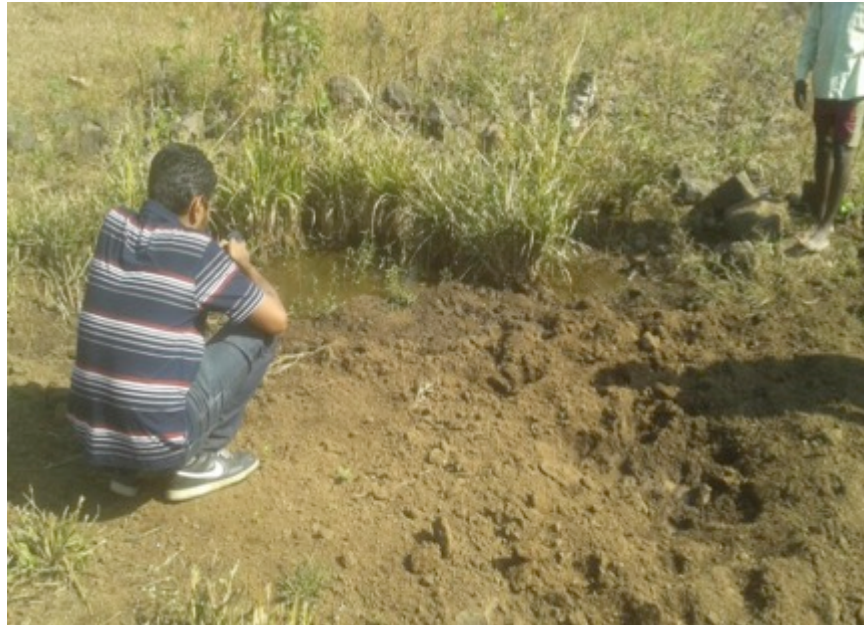
Figure 13 - Buried well in Raipada.

Current status: A few years ago, Raipada was using different well as its primary well. This well was situated by the stream that flows near the habitation, and was washed away by the force of the water. It is possible to see the remnants of the well – it is currently filled with silt as seen in the image below.

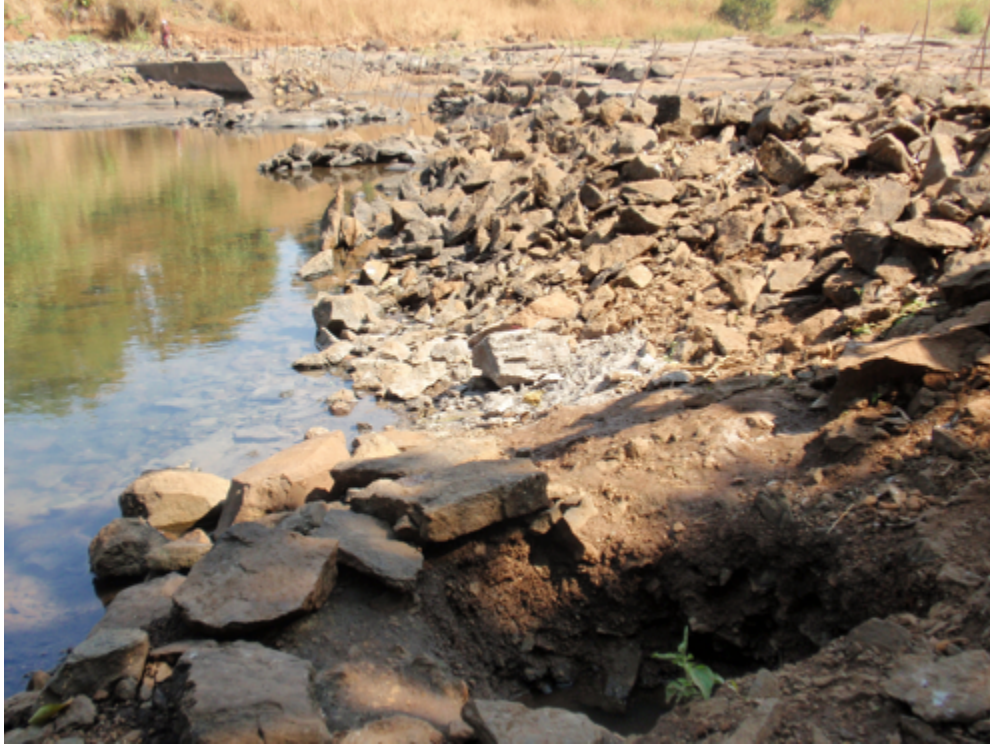
Figure 16 - Photo of river pit used by villagers in Manipada.

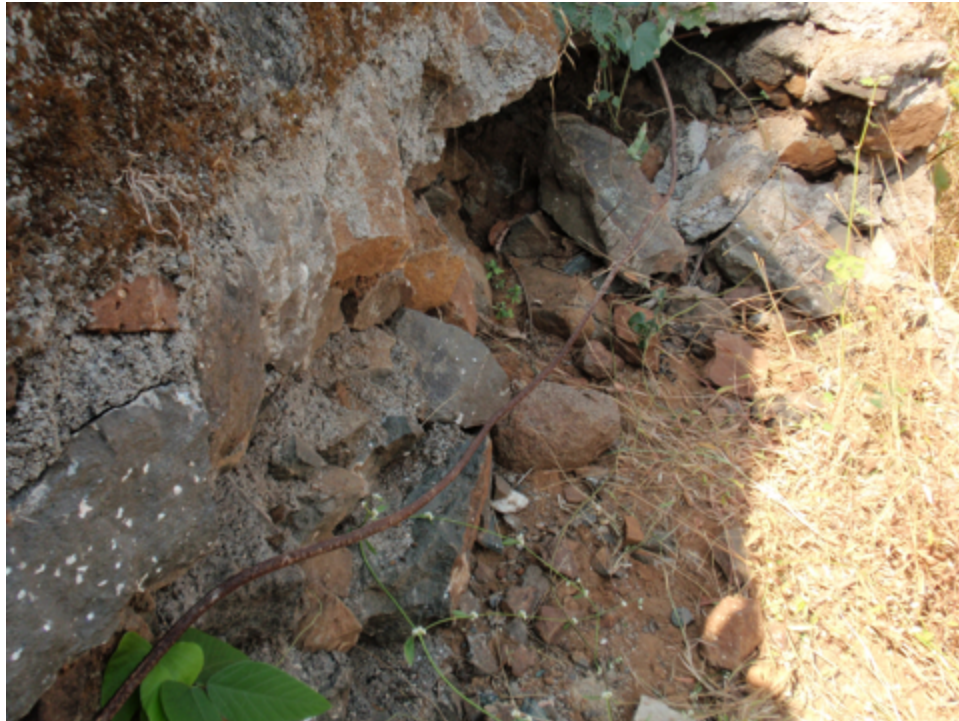
Figure 17 - Photo of broken section of Manipada's Well 2 wall

Current status: A section of base of the wall around Well 2 is severely damaged, as shown in the image below. If the wall is not repaired, that section may break off during one of the subsequent monsoons, and allow the inflow of surface water directly into the well.

Intervention details: TDSC proposes repairing the lining and platform of Manipada's Well 2.

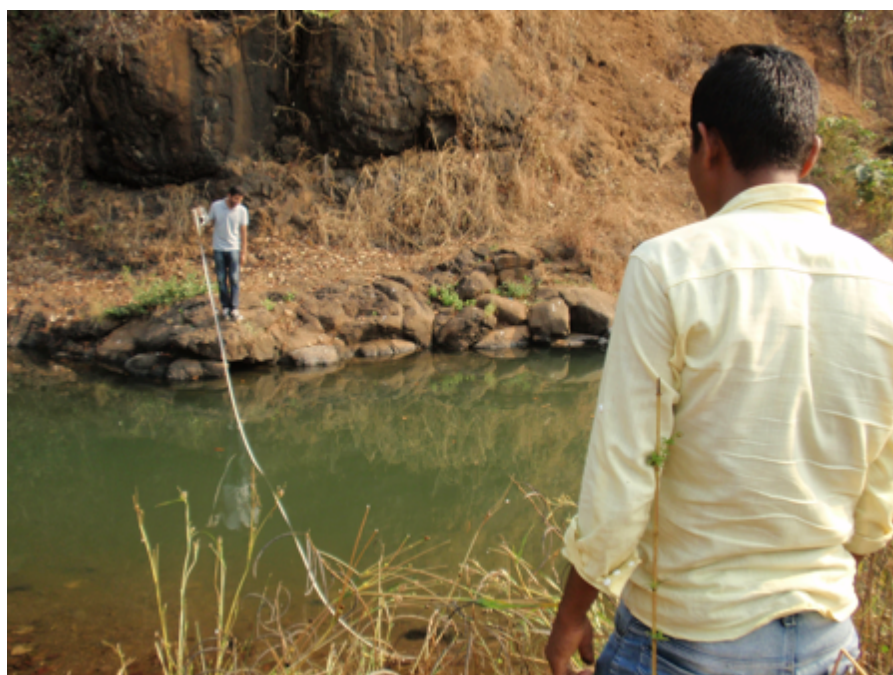
Figure 20 - Photo showing team measuring the stream width at proposed location #1.

- New bund downstream of Well 2 to recharge Well 2 (location 1 on map)
- New bund 50-100 m upstream of Well 2, to store water for irrigation (location 2 on map)

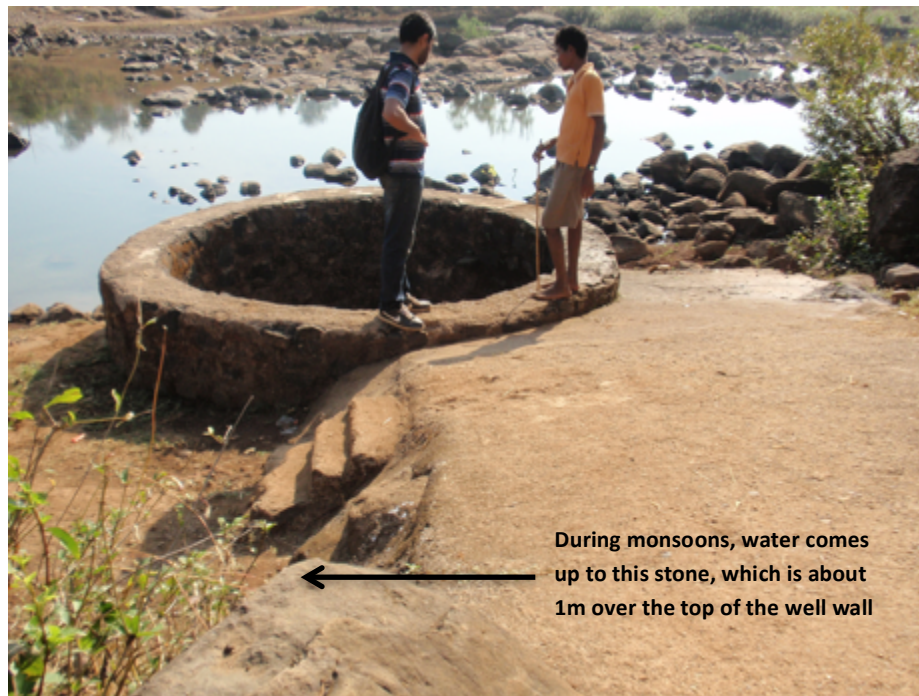
Current status: The primary well in Kirkirewadi stands on the bank of a stream, and during the monsoons the stream levels rises to a point where it submerges the well by over 1 m (see photo below).

Figure 24 – Photos of primary well in Kirkirewadi.

Intervention details: To prevent the well from getting submerged, TDSC proposes increasing the wall height by 2 m, and building a supporting structure around the wall on which villagers can stand to collect water.

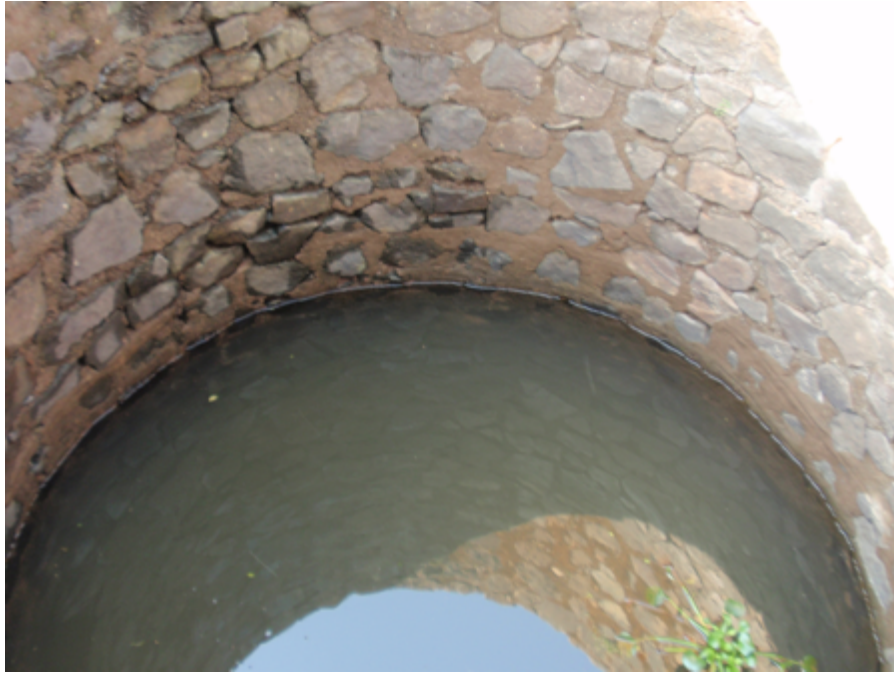
Figure 25 - Photo showing damaged well lining of Kirekirewadi's primary well

Current status: The lining of Kirkirewadi's well is damaged, as seen in the photo below. The damaged lining comprises the well's ability to filter out contaminants, and affects the water quality of the well. Additionally, there is an accumulation of silt at the base of the well, which may be slowing the recharge into the well.

Intervention details: TDSC proposes repairing the lining of the well wall and clearing out the silt at the base of the well.

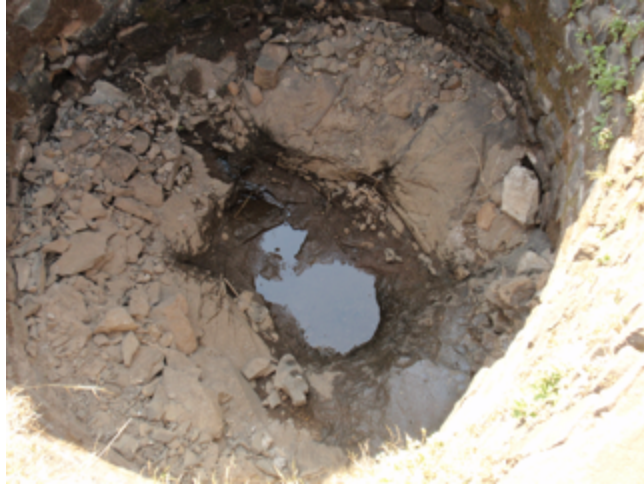
Figure 30 – Photo of Markatwadi Well 1 in November

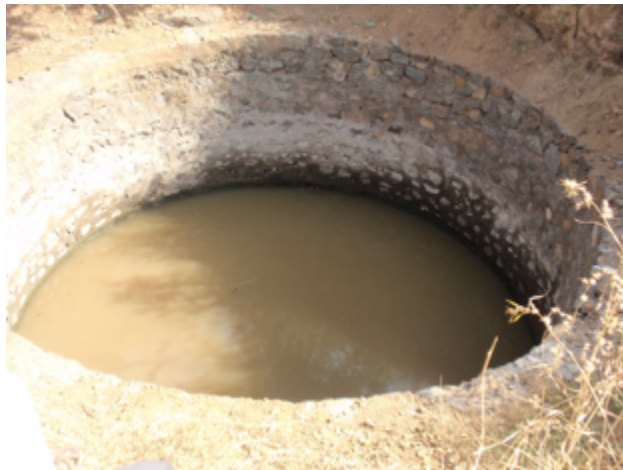
Figure 31 – Photo of incomplete Markatwadi Well 2 (the lining does not even reach ground level).

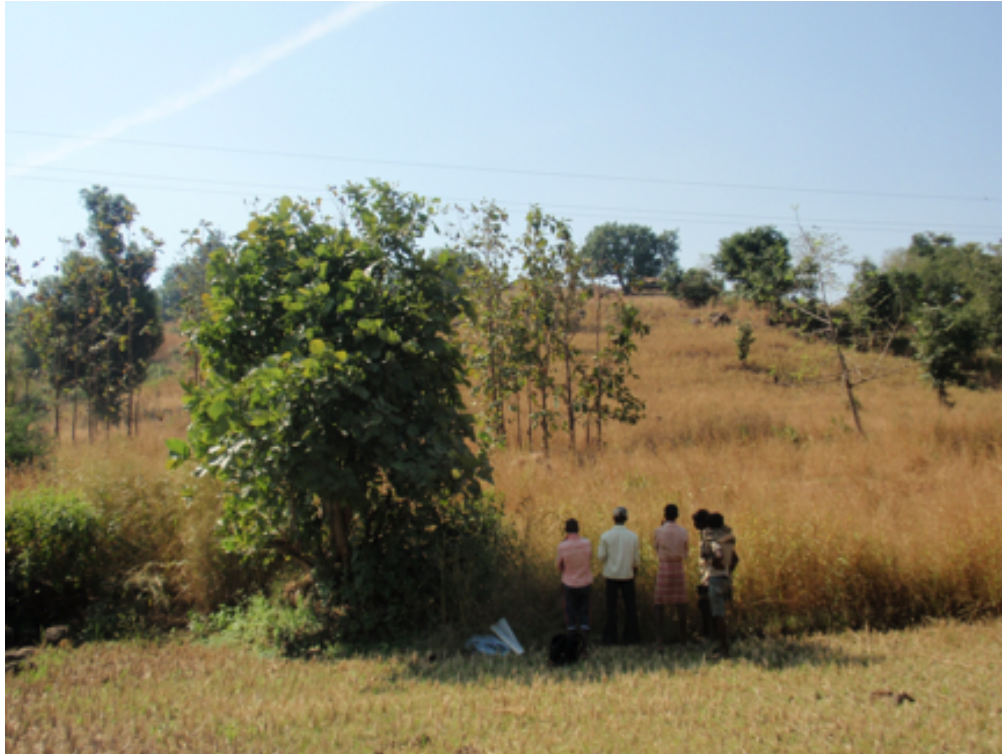
Figure 33 - Photo of site of proposed new well in Markatwadi (where the people are standing).

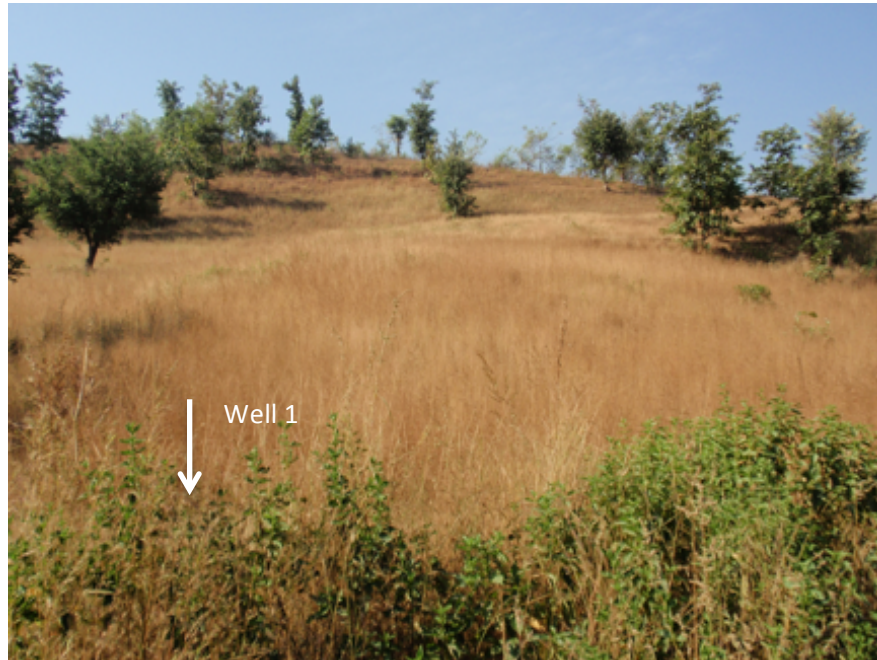
Current status: Markatwadi's Well 1 is downstream of a slope that is suitable for contour trenching, and where there is currently no vegetation cover (see image below). Constructing contour trenches on this hill will increase recharge into Well 1 and improve the soil moisture in the area.

Figure 35—Photo showing site for contour trenching upstream of Markatwadi Well 1.

Intervention Details: TDSC proposes building contour trenches in the area shown in the images above. The basic design outputs of the trenches (total number of trenches, number of rows, distances between trenches) have been calculated for the area delineated above, which is approximately 8000 m³. The designs were prepared using guidelines from the NREGA Watershed Works Manual by Samaj Pragati Sahayog.

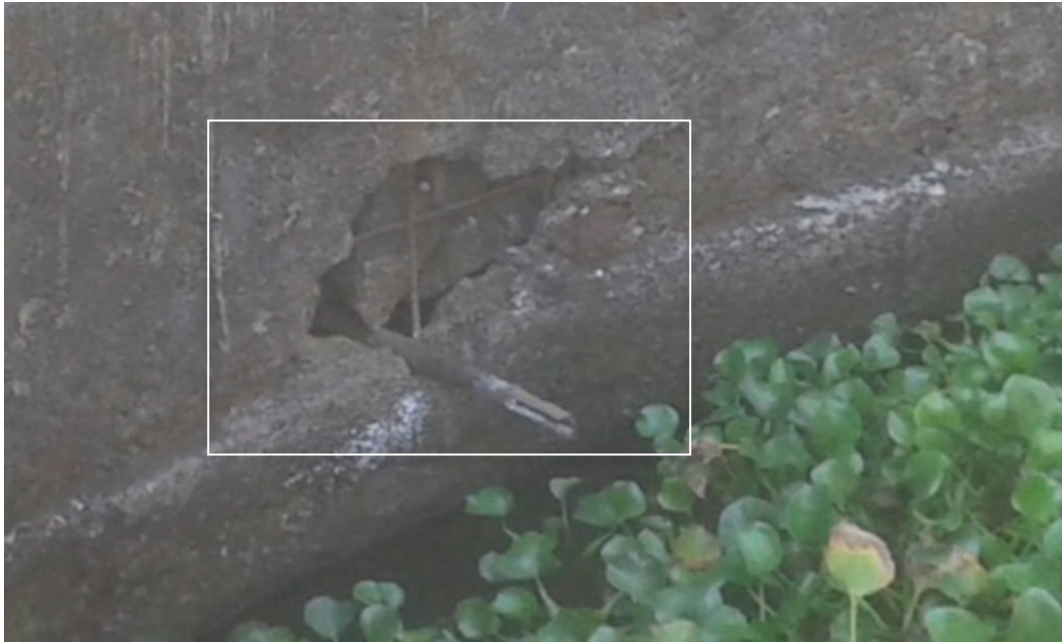
Figure 37 – Damaged well lining

Current status: There is scope for improving the condition of Well 1 (one of the primarily wells). The lining of Well 1 currently has a large hole, with a broken bamboo pipe going through it (see image below). Muddy surface water could easily enter the well directly through the break, compromising well's water quality. The space immediately around the well is being used for washing purposes, which is creating an additional source of contaminated water to enter the well.

Intervention details: TDSC proposes repairing the lining of Bhojpada's Well 1, and building a platform for the well along with a designated area specifically for washing and cleaning. The schematic are shown in the figure below.

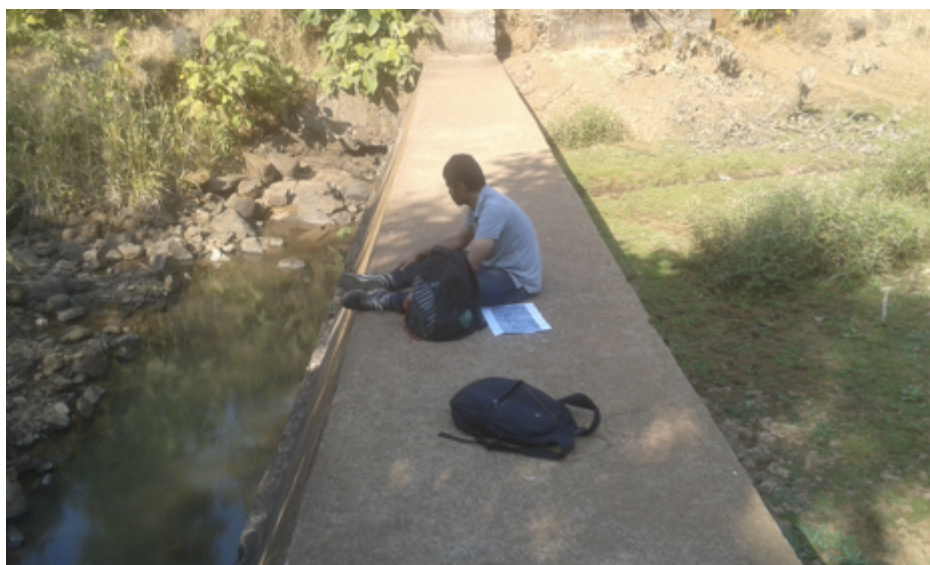
Current status: Bhojpada Bund 1 (seen in the Google Earth image above and photo below) is situated by the fields, which are approximately 8 m higher in elevation. There is almost no water stored behind the structure because of leakage, but the bund structure appears to be repairable. If the bund is repaired and can store water up to its FSL, that water could be used as a source of irrigation water. The bund is leaking at two places, and has accumulated silt.

Figure 39 - Photo of Bhojpada Bund 1 (left side is downstream)

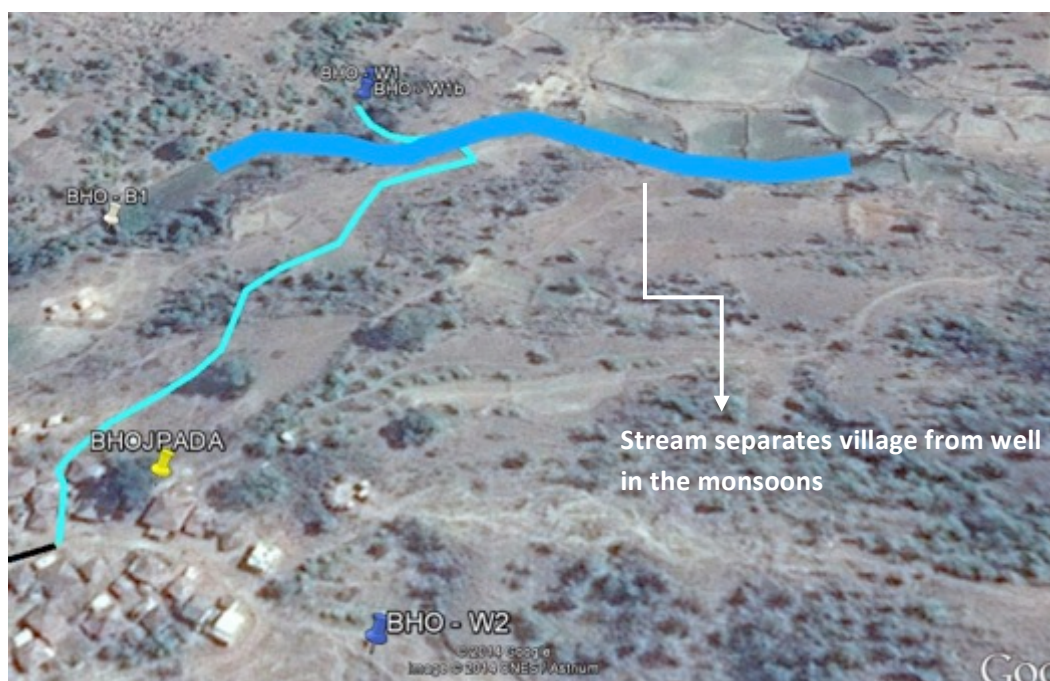
Current status: The path to the primary wells (Well 1 and 1b) gets submerged during the monsoons. TDSC proposes providing a solution that allows better accessibility to Bhojpada's primary water source during the monsoons; this could be either through building a short footbridge over the stream or by providing a small-scale pumping solution that allows water to be pumped into the habitation year round.

Image of stream separating well from village
