# **Watershed Interventions for Kurlod and Botoshi**

## **Phase II**

July 2015

Technology and Development Solutions Cell (TDSC)  
Centre for Technology Alternatives for Rural Areas (CTARA)  
Indian Institute of Technology, Bombay (IITB)

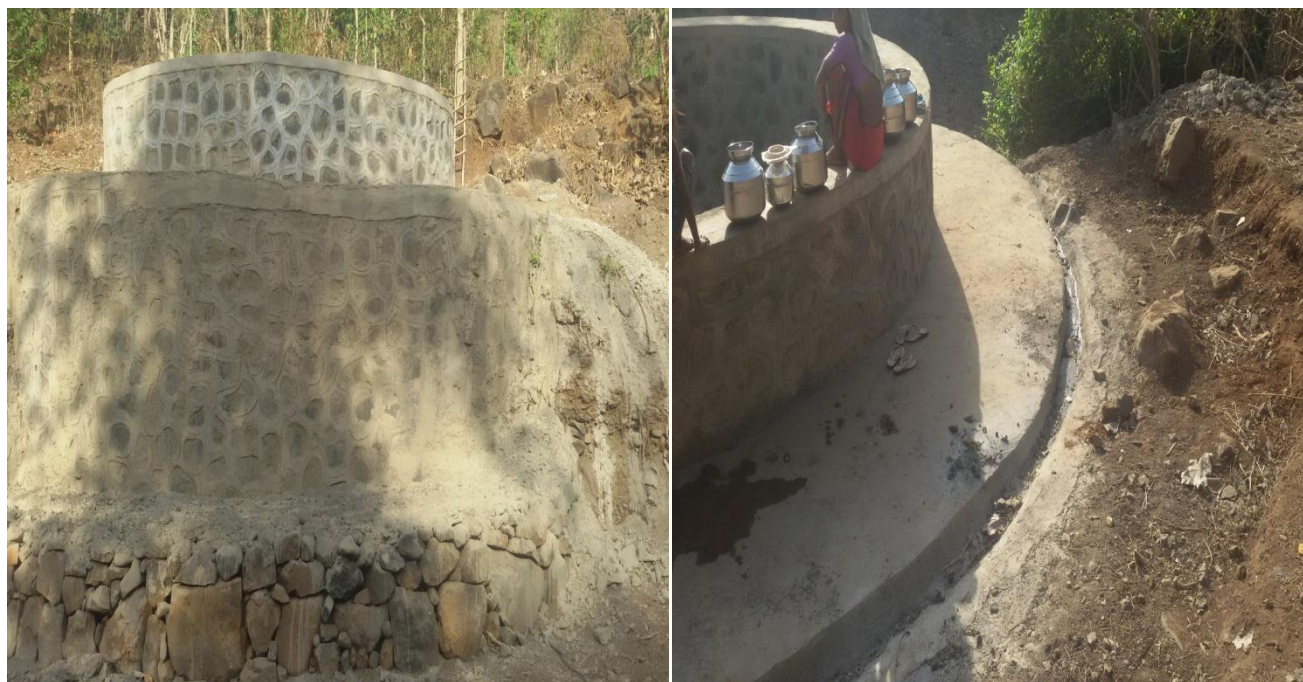
Figure 3 Well lining repair and drainage construction at Kurlod well

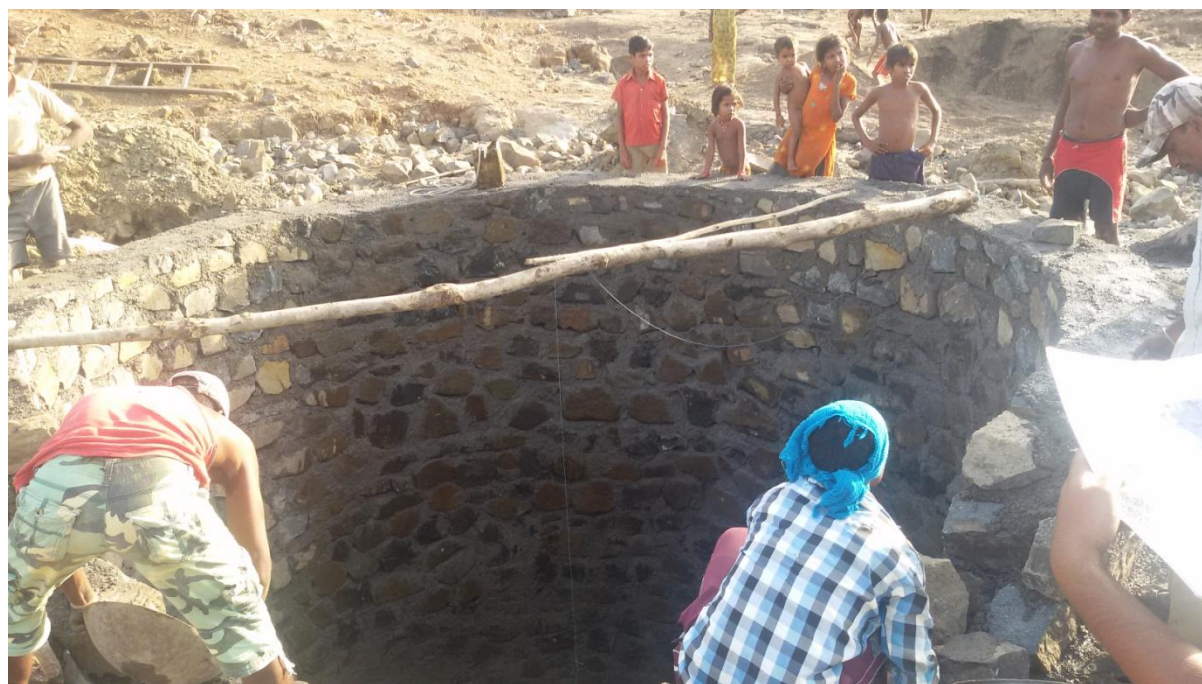
Figure 4 New well construction at Raipada

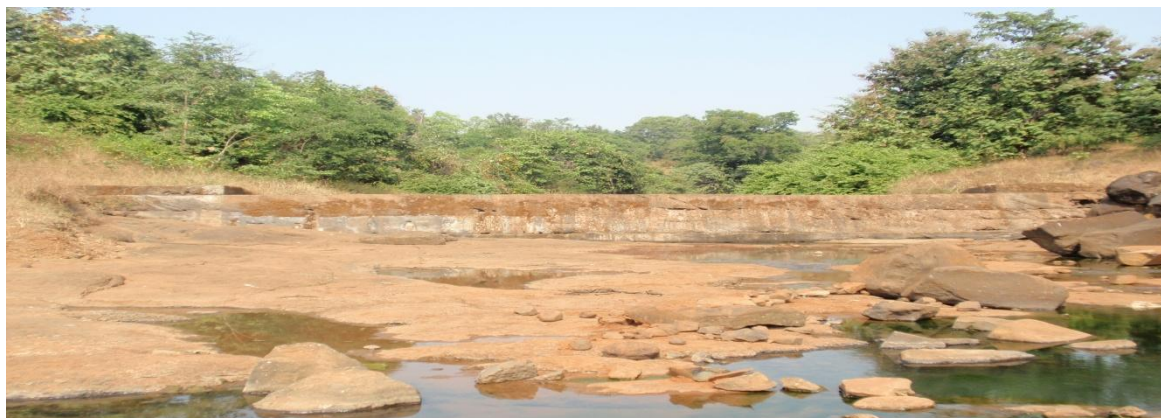
Kurlod's existing bund stands on a stream that flows into the Pinjal River. The bund has a significant leakage problem; by the end of November virtually all the water stored leaks out. Large cavities and cracks can be seen at the base and in the body of the bund. AA2 agricultural area can be irrigated which is at elevation of 23m (right side of upstream). **However, as this bund will support the primary drinking water well 4 (W4), it is advisable to not use this bund for agricultural purpose.** Latitude and longitude of this bund is 19°48'46.40"N and 73°18'31.93"E.

Figure 8 Current status of broken bund (BR1) in Kurlod

Name	Height (m)	Back water Length (m)	Length of bund (m)	Volume (m <sup>3</sup> )
BR1	2.4	110	19.2	1267

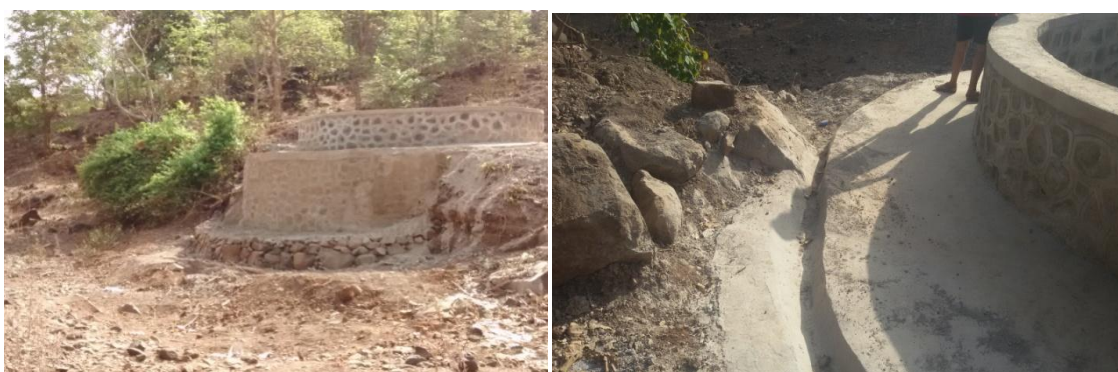
Figure 9 Current status of Kurlod well (W4) after repair

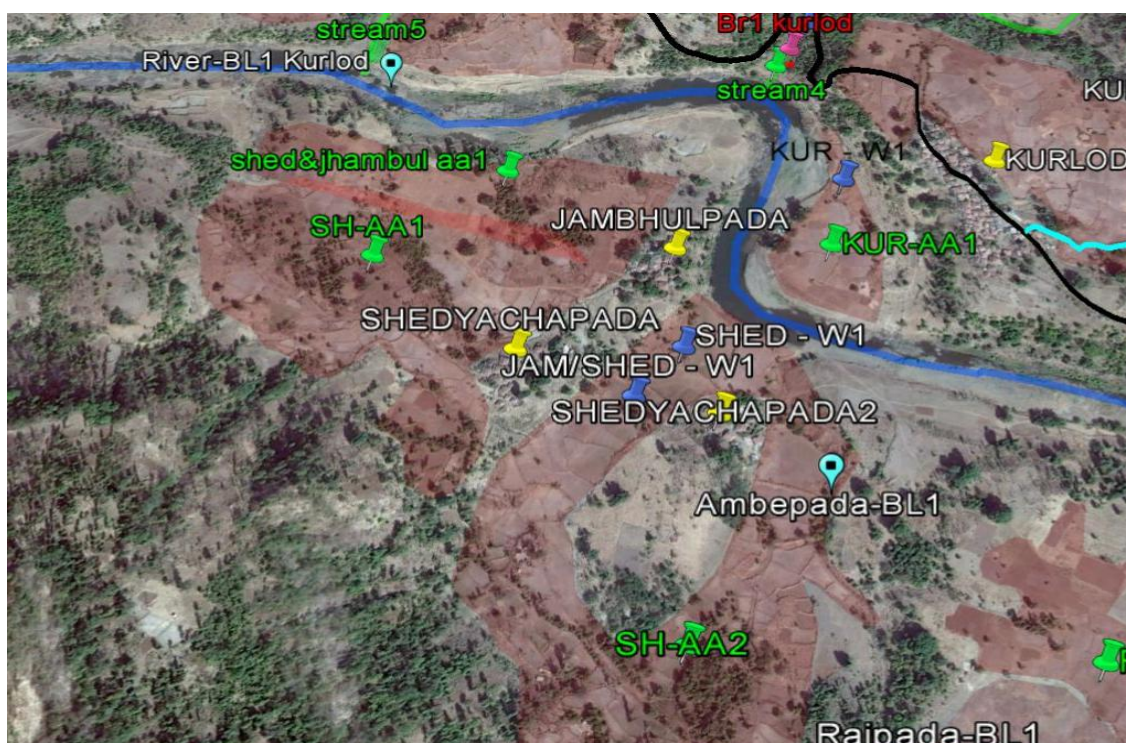
Figure 11 Agriculture areas of Shedyachapada and Jambhulpada.

Shedyachapada and Jambhulpada are two small neighbouring habitations with a combined population of 150. There are two wells in the vicinity of the habitations, this area belongs to low stress zone. One stream was found near Shedyachapada recently known as Ambechapada. Volumetric calculations show that irrigational demand cannot be satisfied with construction of bund in Ambechapada.

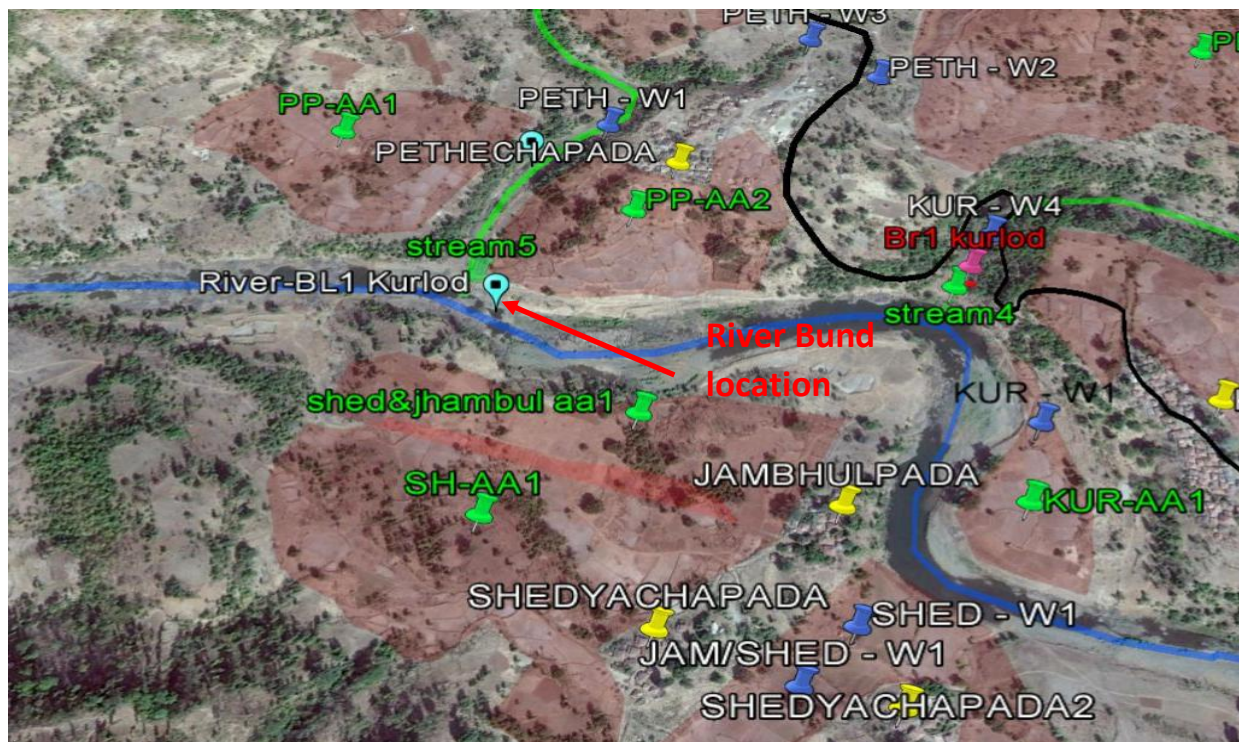
River Bund (BL-1) can irrigate the area of Shedyachapada, Jambhulpada and some parts of Kurlod, Pethechapada. Farm land of Shedyachapada and Jambhulpada are at 8 m and 20 m respectively. (Right side of upstream)

Figure 12 River Bund location (BL1)

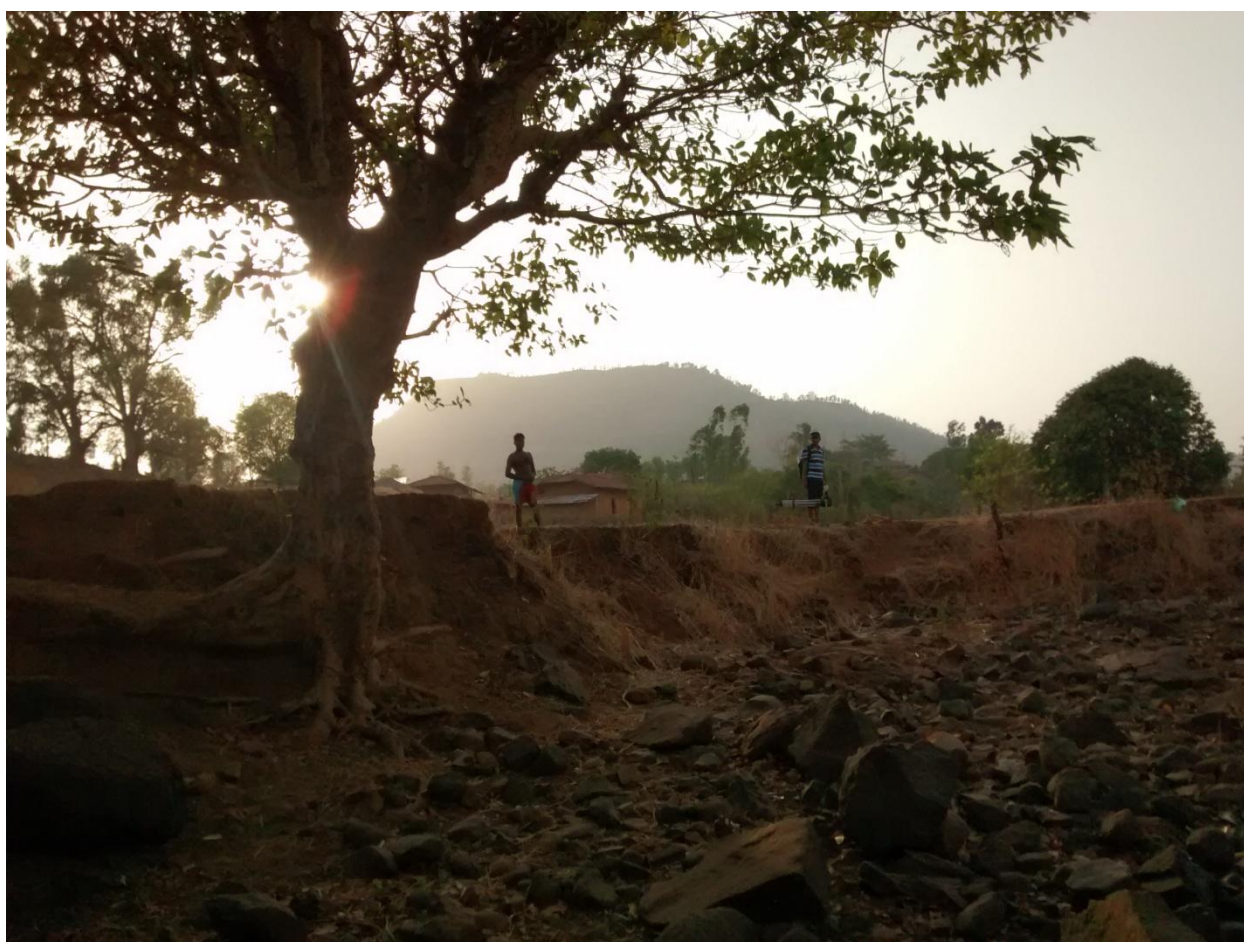
Ambechapada bund (BL1) can partially solve the problem of Shedyachapada. Topography of area shows that bund height cannot be increase beyond 1.5m. Latitude and longitude of proposed bund is 19°48'23.54"N,73°18'37.59"E

Figure 13 Topography of Ambechapada Bund (BL1) location.

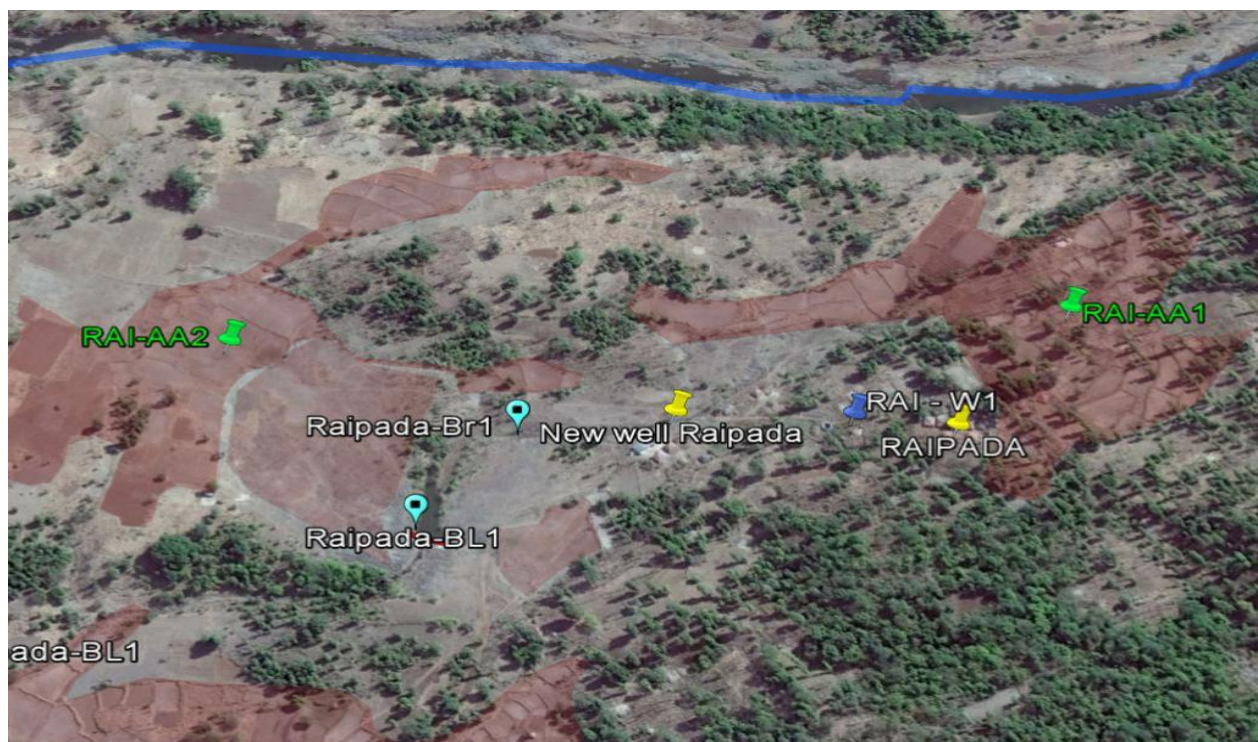
Figure 14 Agriculture areas of Raipada.

Raipada has a population of 80 and currently has one well (Well 1) that lasts through the year but that had a major water quality problem just after the monsoons, in October. TDSC collected a water sample in November suspecting a high concentration of iron, but did not find exceptionally high concentrations of iron. There is a bund within the fields (BL1 in image below), about 250 m from the habitation, which has minor leakage and holds water until February. There is an additional bund (BR1) that is broken from the middle, holds no water. The bund BR1 requires minor repair work and a gate in order to be functional again.

Agricultural area AA2 can be irrigated with minor repair of bund (BL1). The fields are at elevations of 8 m and 4 m, from the left and right side of upstream, respectively. De-siltation is needed to maximize the capacity of bund. Latitude and longitude of bund is 19°48'11.98"N and 73°18'43.40"E

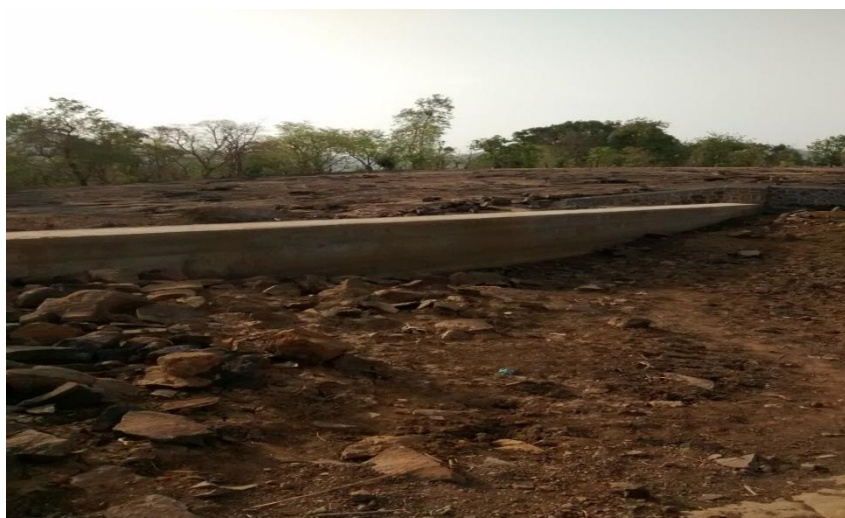
Raipada's existing bund (see photos below) holds water until February, and was built with the intention of providing water for irrigation. Physical details about the bund are in the table below. The bund has minor leaks in a few places: if they are repaired the bund would retain water beyond February, and a pumping system can be installed in the future to pump water to the fields for a second crop. Siltation has been observed during our visit.

Figure 16 Raipada Bund condition in 1<sup>st</sup> week of June

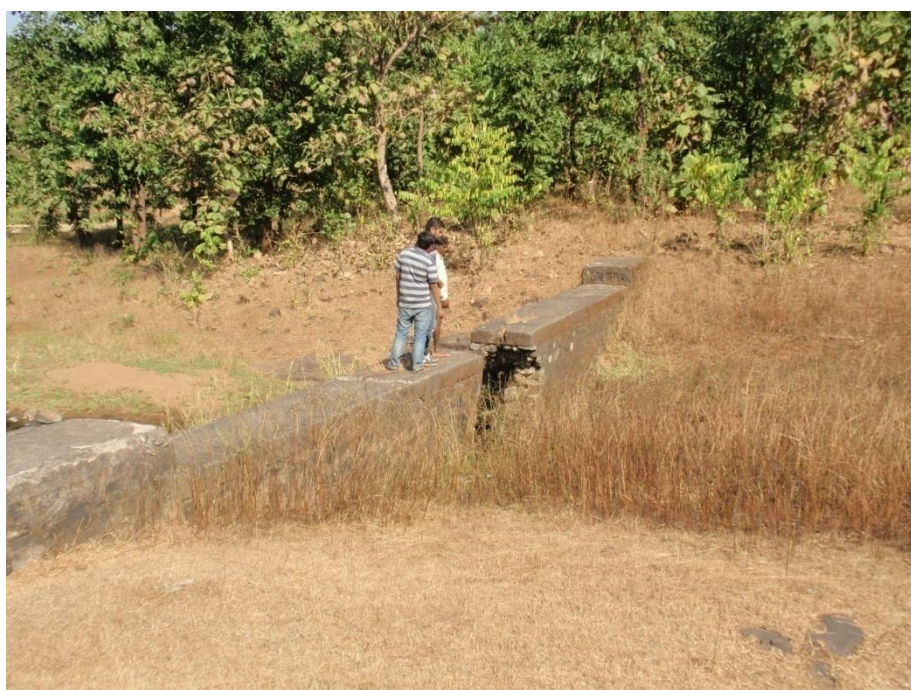
There is an additional bund in that is broken from the middle, holds no water and has little scope for repair. Repair of this bund would irrigate partial area of AA-2 which is almost at ground level. Latitude and longitude of bund is 19°48'9.90"N and 73°18'46.80"E

Figure 17 Broken bund (BR1) of Raipada

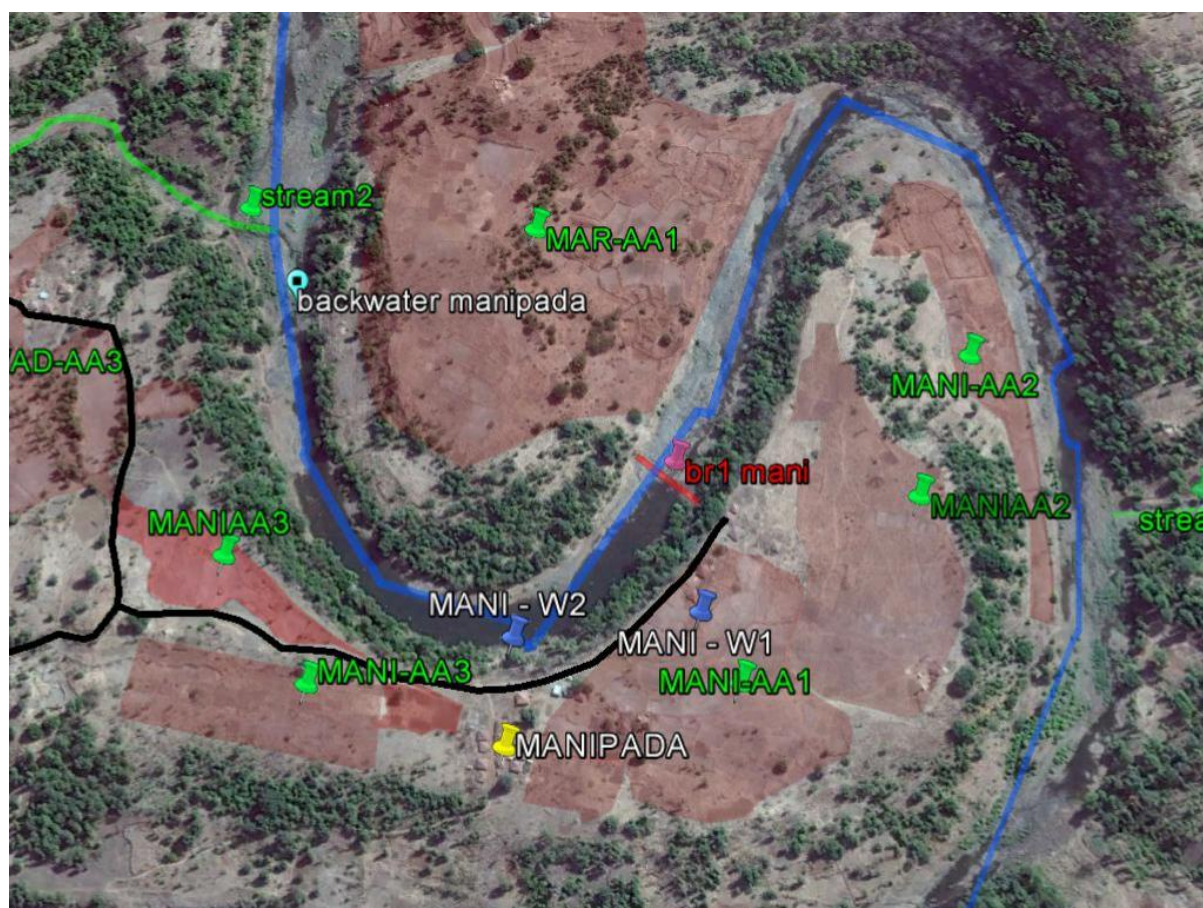
Figure 18 Agriculture areas of Manipada.

Manipada has a population of 60 and two wells, one that holds water through the year (Well 2) and one that dries in October (Well 1). Repair of well (W2) was completed during our visit. A partially complete river bund (BR1) was also completed. The river bund can alone meet the irrigational demand of the habitation and also recharge the primary well (W2).

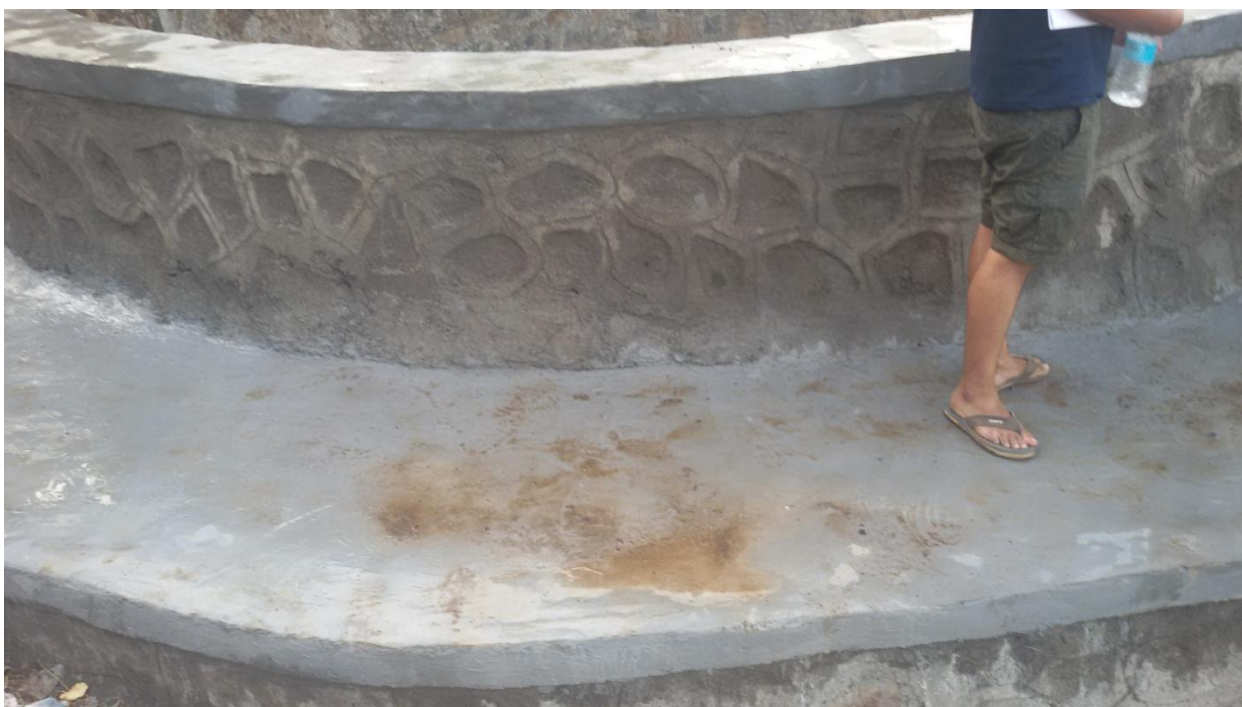
The repair work of Well 2 (W2), consisting of a new platform and repair to the damaged well wall, was completed during our visit period. The problem of well accessibility remains, however.

Figure 19 Present condition of well (w2)

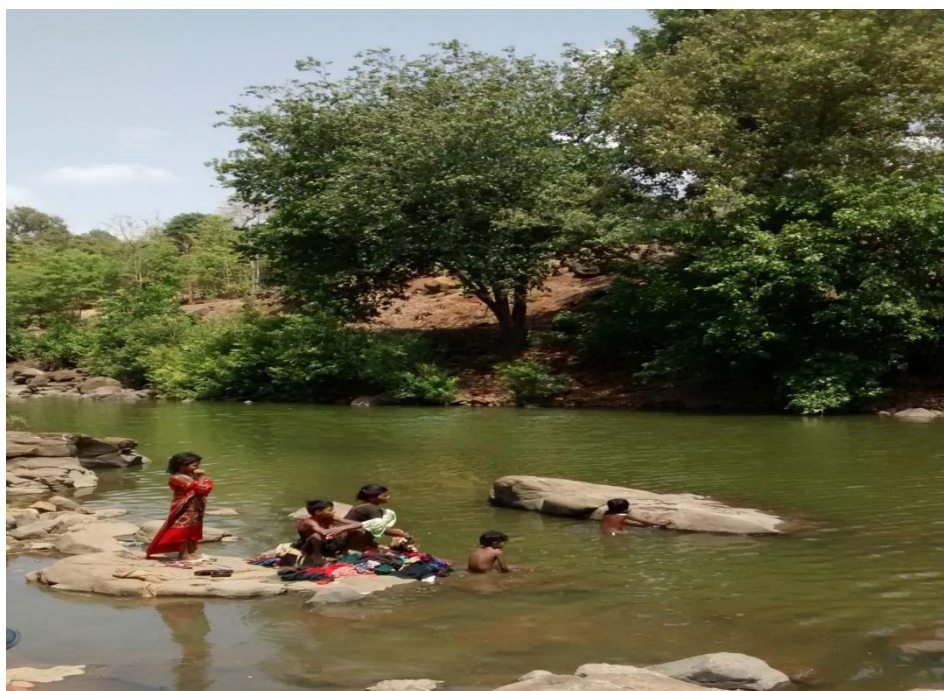
Figure 20 Backwater of Manipada (670 m from Manipada river bund)

\*Volumetric calculation for 1.5 meters of height corresponds to water level of 1<sup>st</sup> week of June.

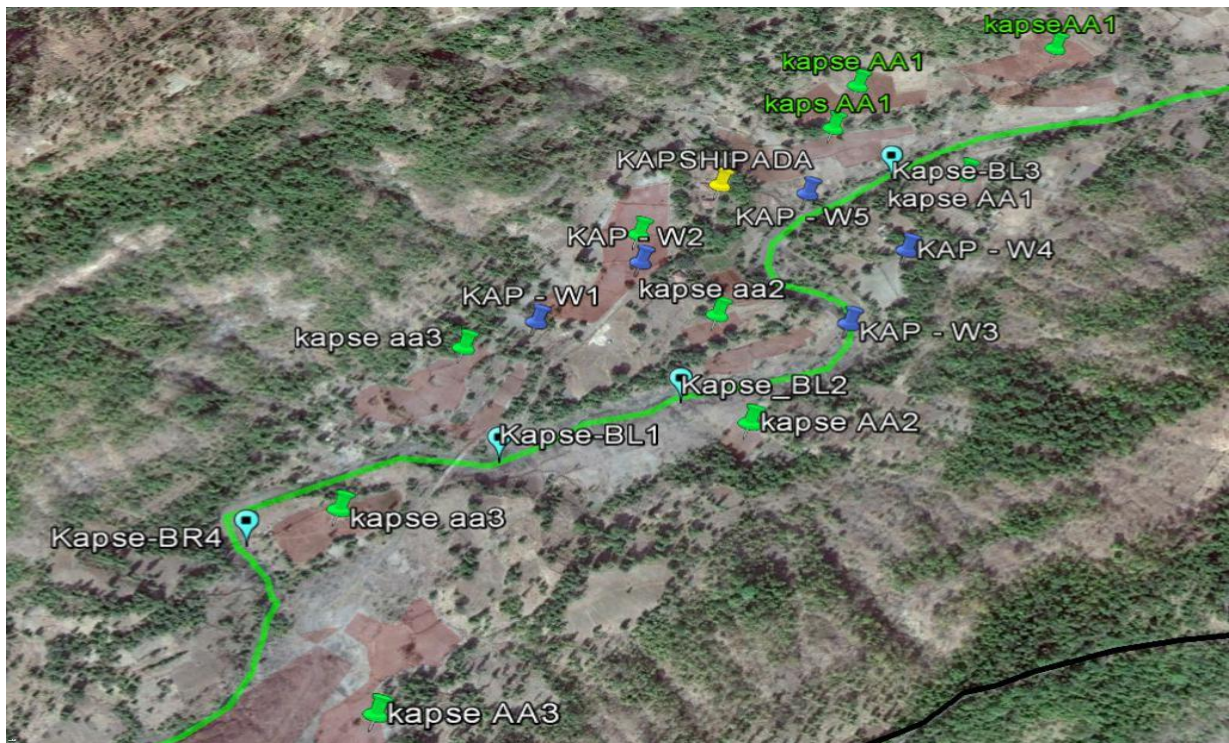
Figure 22 Agriculture areas of Kapsepada

Kapsepada belongs to low stress zone and it has got five (5) wells. Well 5 have water throughout the year generally used for domestic purpose. Kapsepada's existing bund stands on a stream that flows into the Pinjal River. The bund has a significant leakage problem; by the end of November virtually all the water stored leaks out. Large cavities and cracks can be seen at the base and in the body of the bund.

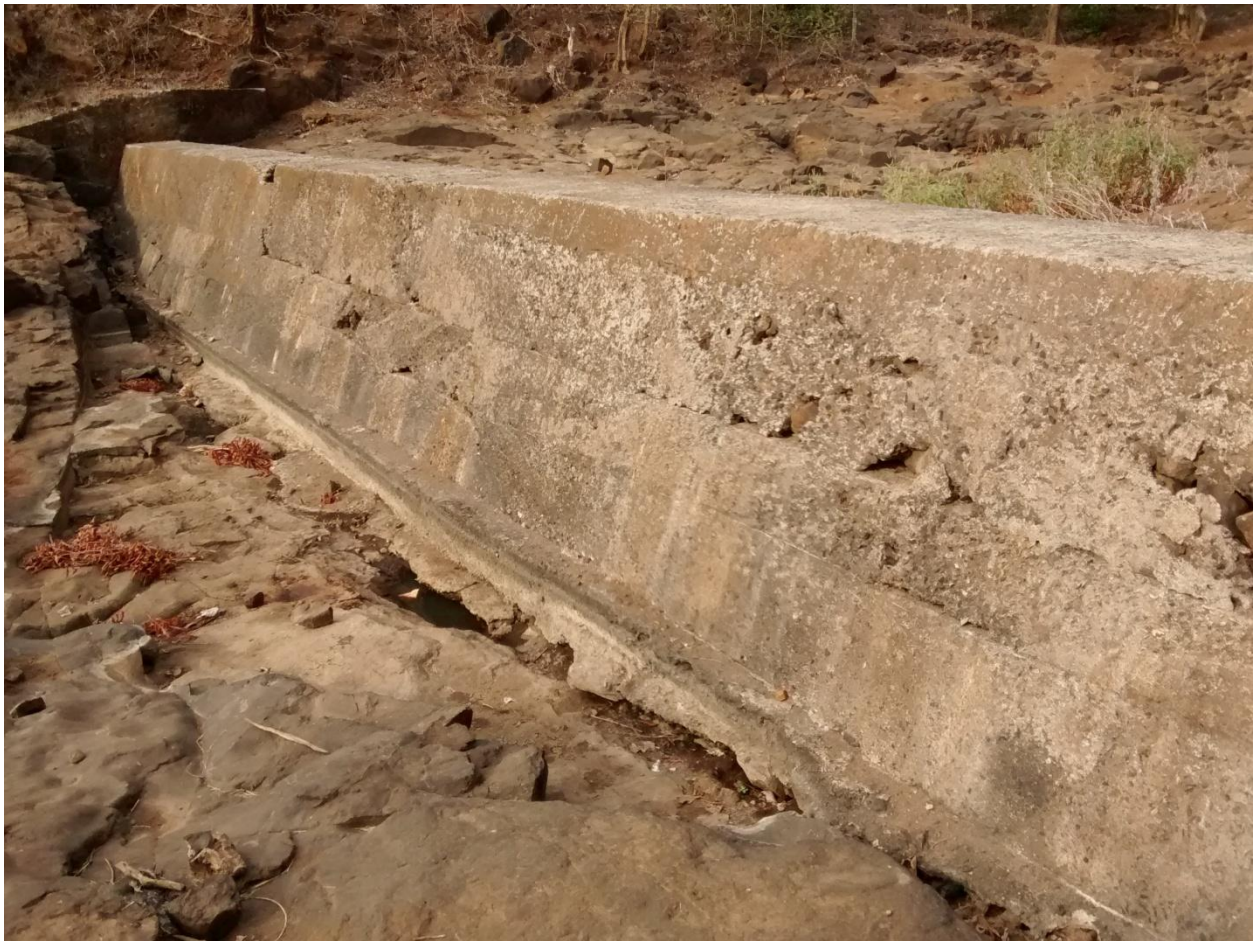
Figure 23 Current status of Kapsepada bund (BL4)

Repair of broken bund (BR4) is essential as it has a large volumetric storage of water. Area AA3 can be easily irrigated. It can also solve the drinking water problem of Kapsepada.

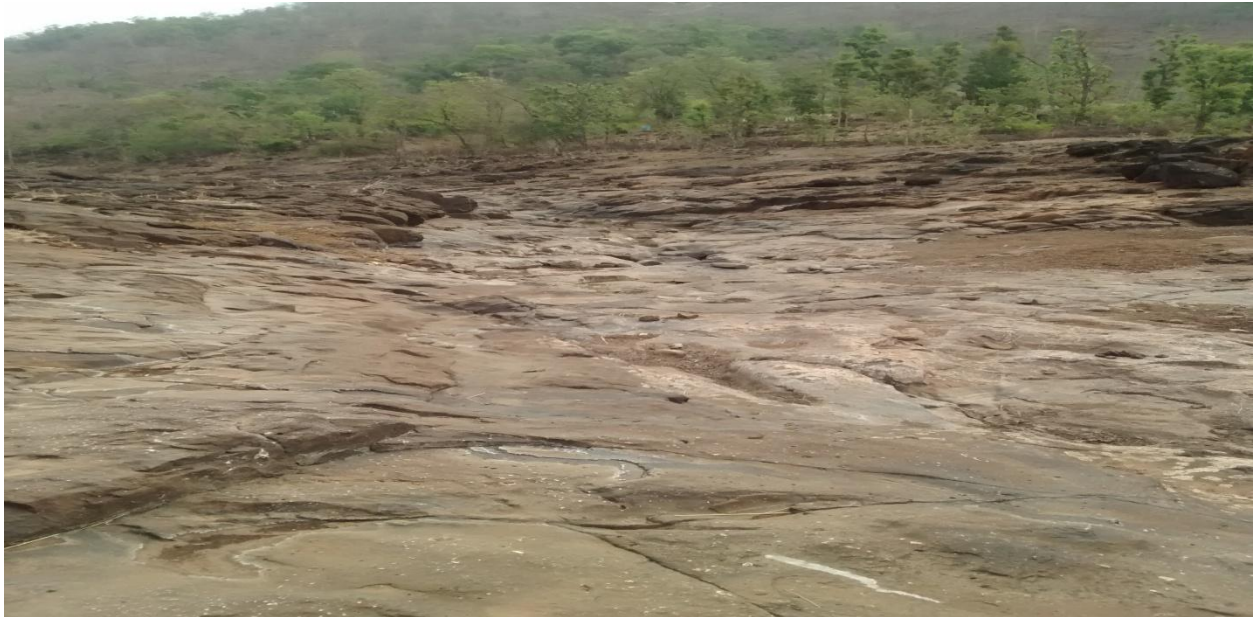
Bund construction at location 2 (BL2) is difficult task as it requires skilled labour and machinery due to hard rock bed. Storage of the bund is also very less. AA2 can be irrigated by this bund. AA2 is at an elevation of 15 m and 5 m on left and right side of upstream, respectively. Latitude and longitude of bund is 19°49'27.08"N and 73°18'3.63"E.

Figure 24 Hard bed rock at BL2 in Kapsepada

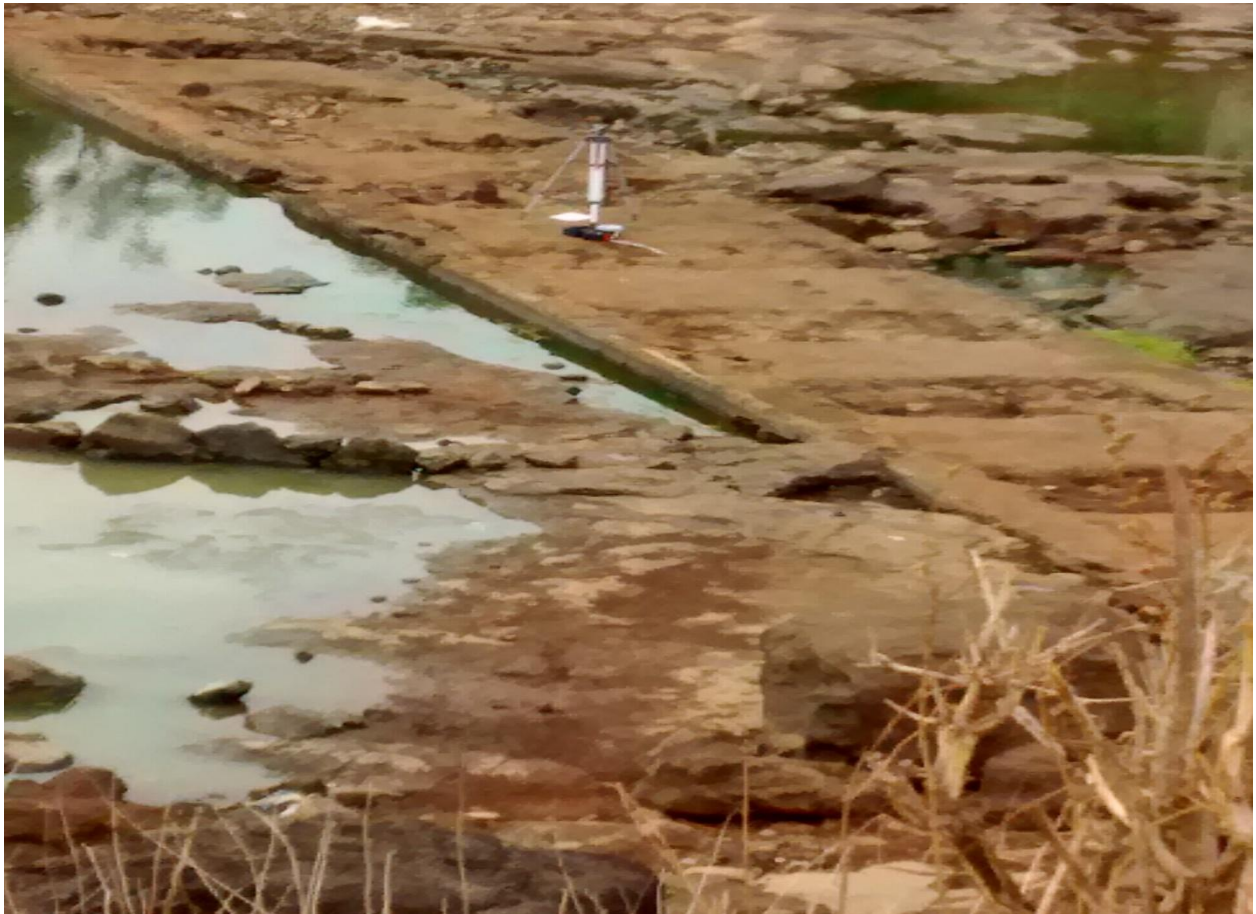
Currently Botoshi does not have any river bund or stream bund. Construction of Broken bund (BR1) is essential as it can irrigate area (AA2 and some parts of AA1). To irrigate other part of AA1 pump needs to be installed. Proper design of this bund can solve the accessibility problem of Botoshi.

Figure 26 Present condition of broken bund (BR-1)

**Proposed intervention:** there is an urgent need of bund (BR1) to be constructed as it can solve both the irrigational and accessibility problem of Botoshi. Construction of this bund can store huge amount of water, enough to serve the irrigational purposes of Botoshi in any season. Base of broken bund was considered as datum and volume was calculated. Agricultural area AA1 and AA2 is at an elevation of 12 m on left side of upstream. Latitude and longitude of bund is 19°47'54.05" and 73°20'18.69"E.

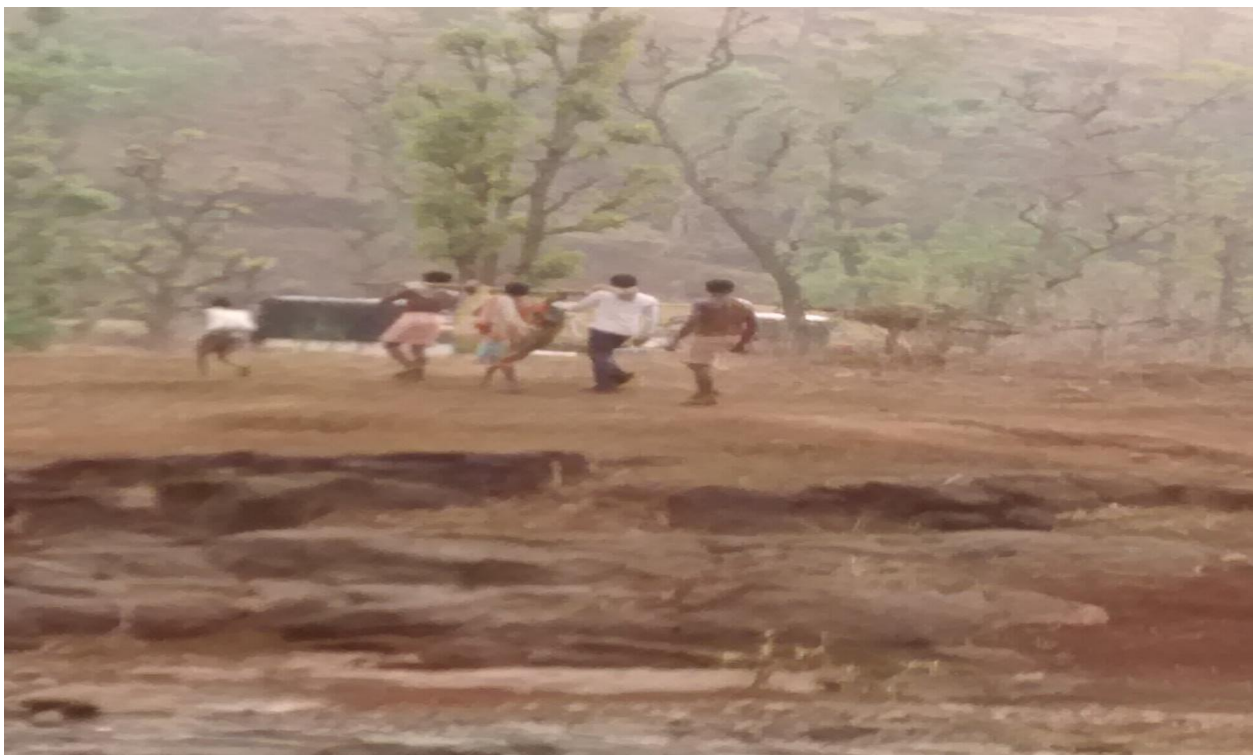
Figure 27 Accessibility problem of Botoshi.

**River bund cum bridge design must be provided as Botoshi faces accessibility problem in rainy season.**

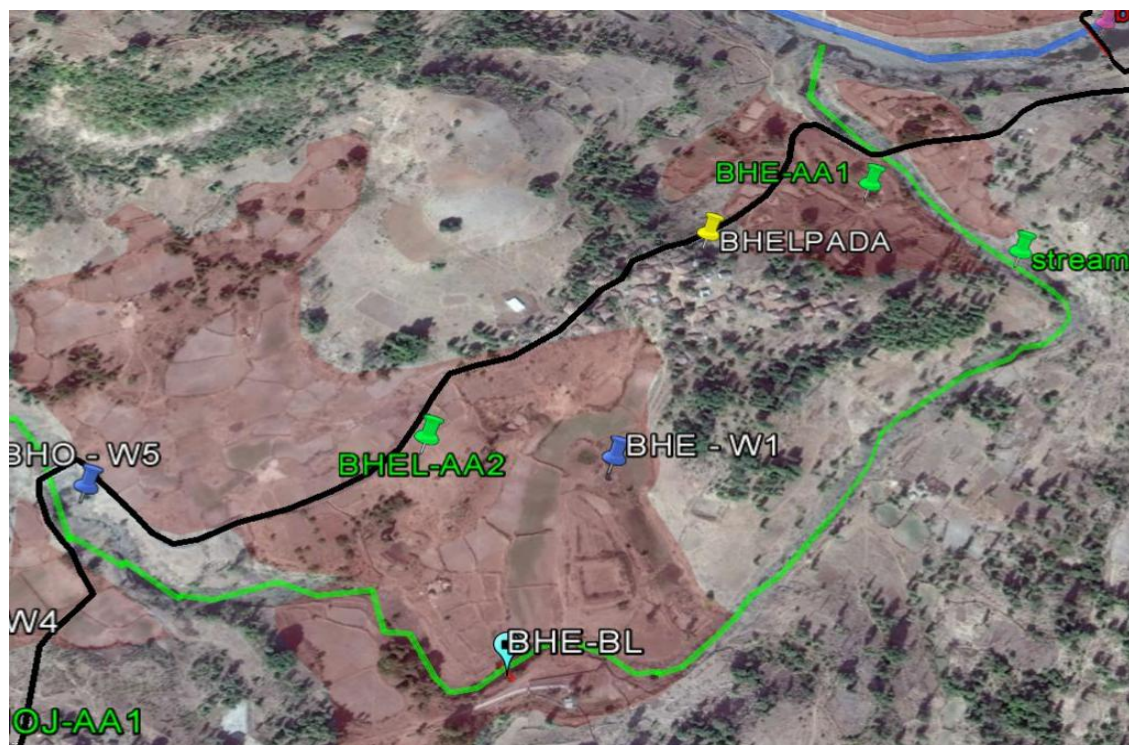
Figure 29 Agriculture areas of Bhelpada.

Bhelpada is the largest habitation in Botoshi with a population of 450. It has one well that lasts until June, after which villagers rely on the river. There is a broken bund approximately 500 m from the habitation. Broken bund (BL1) is at perfect location as it covers maximum agricultural area. Bund (BL1) is in totally damaged condition

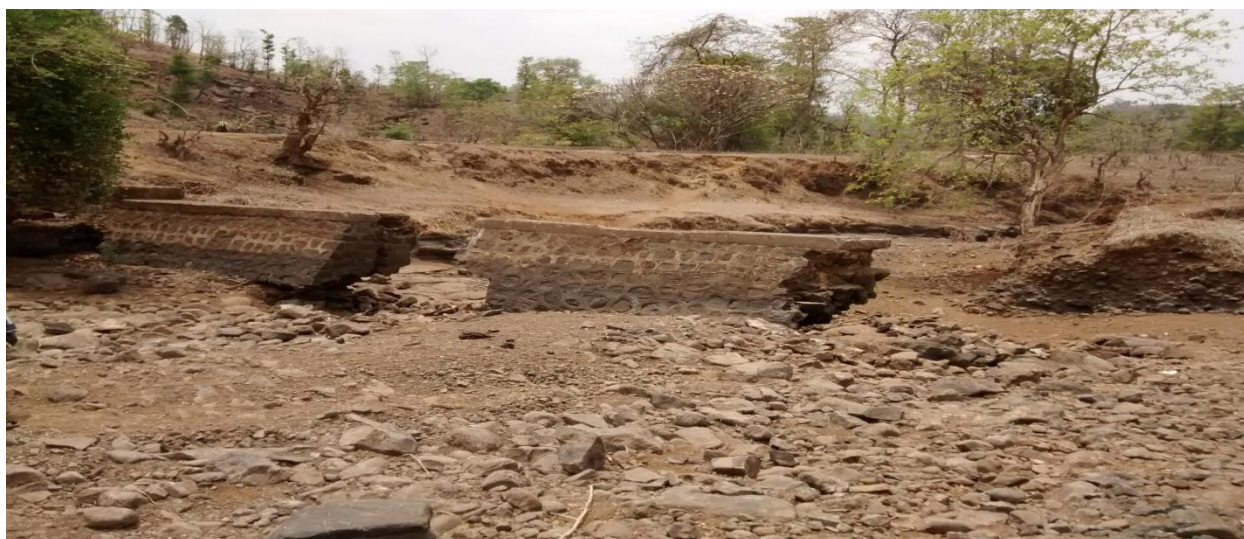
Bhelpada has large agricultural area. Repair of bund is required to improve the livelihood of villagers. Currently there exists a bund which is totally in damaged condition. Agricultural

area AA2 can be irrigated with the help of this bund which is at an elevation of 5m (right side of upstream). Latitude and longitude of bund is 19°47'28.92"N and 73°20'31.93"E.

Figure 30 Present condition of Bhelpada Broken bund (BR1)

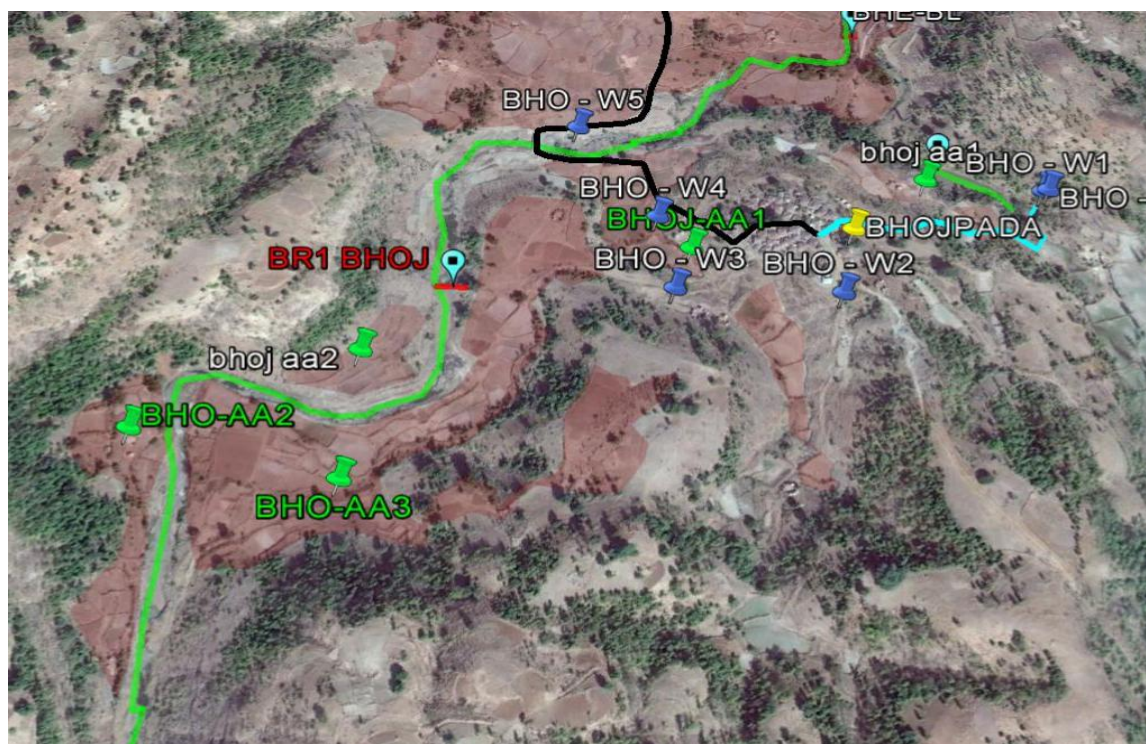
Figure 31 Agriculture areas of Bhojpada

Bhojpada has a population of 340 and has five wells, two of which hold water all year round (Well 1 and 1b). The Google Earth image below shows the locations of all five wells. Well 1 and 1b are the primary wells, and lie adjacent to each other and on the bank of a stream that leads to the Pinjal River.

Bhojpada also has two bunds (BL1 and BR1 in image below). Bund (BR1) is almost silted and entirely broken from the middle and cannot be repaired. Bund (BL1) is leaking but can be greatly enhanced by repairing the structure.

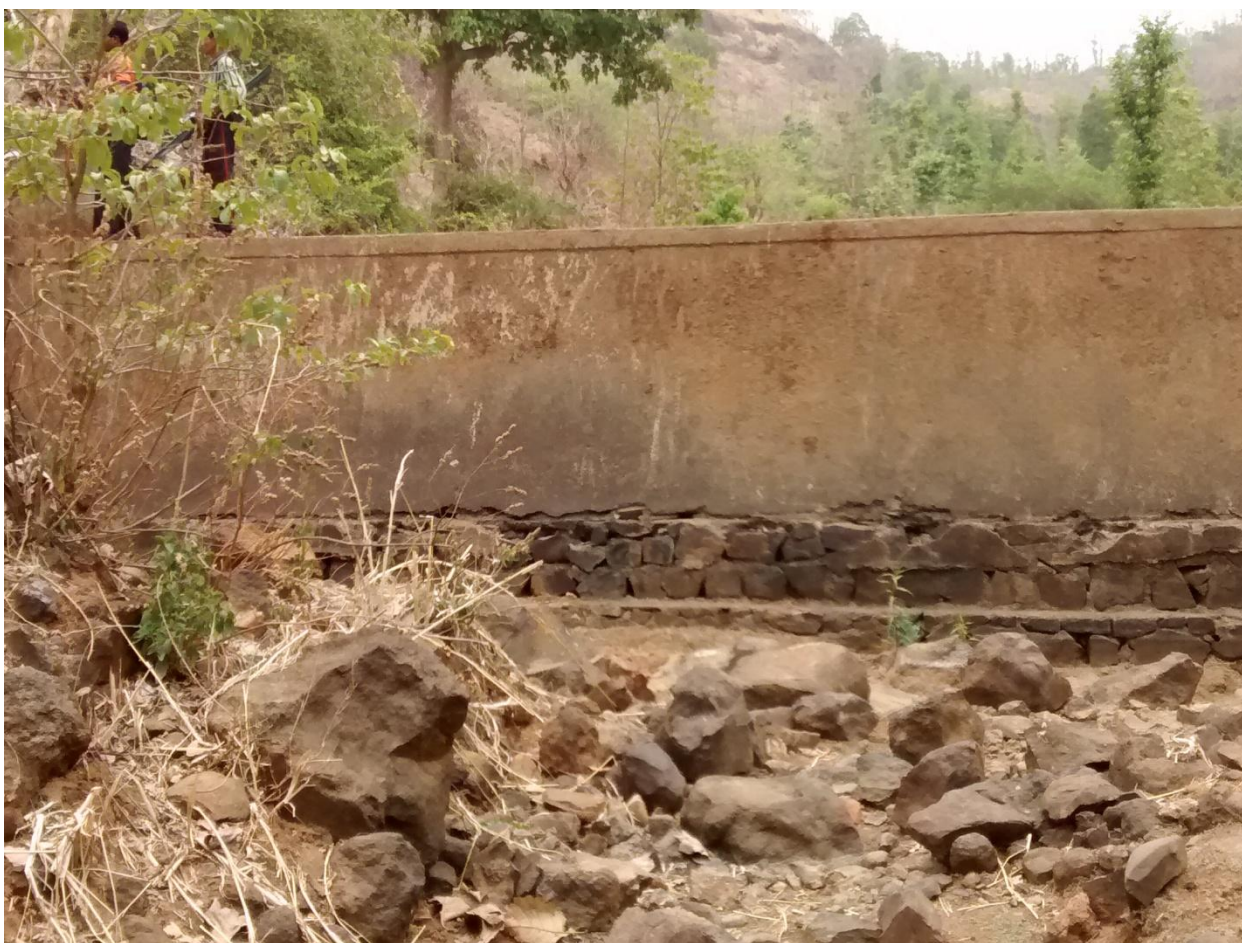
Bund (BL1) has minor leakage problem, but water is available till December. Its main purpose is to recharge the well (W1 & W1b), water is available though out the year in these two well. Agricultural area nearby to this bund is very less. Minor repair work can be done here to prevent leakage from the bottom. Latitude and longitude of bund is 19°47'22.62"N and 73°20'36.14"E.

Figure 32 Present Condition of Bhojpada Bund (BL1).

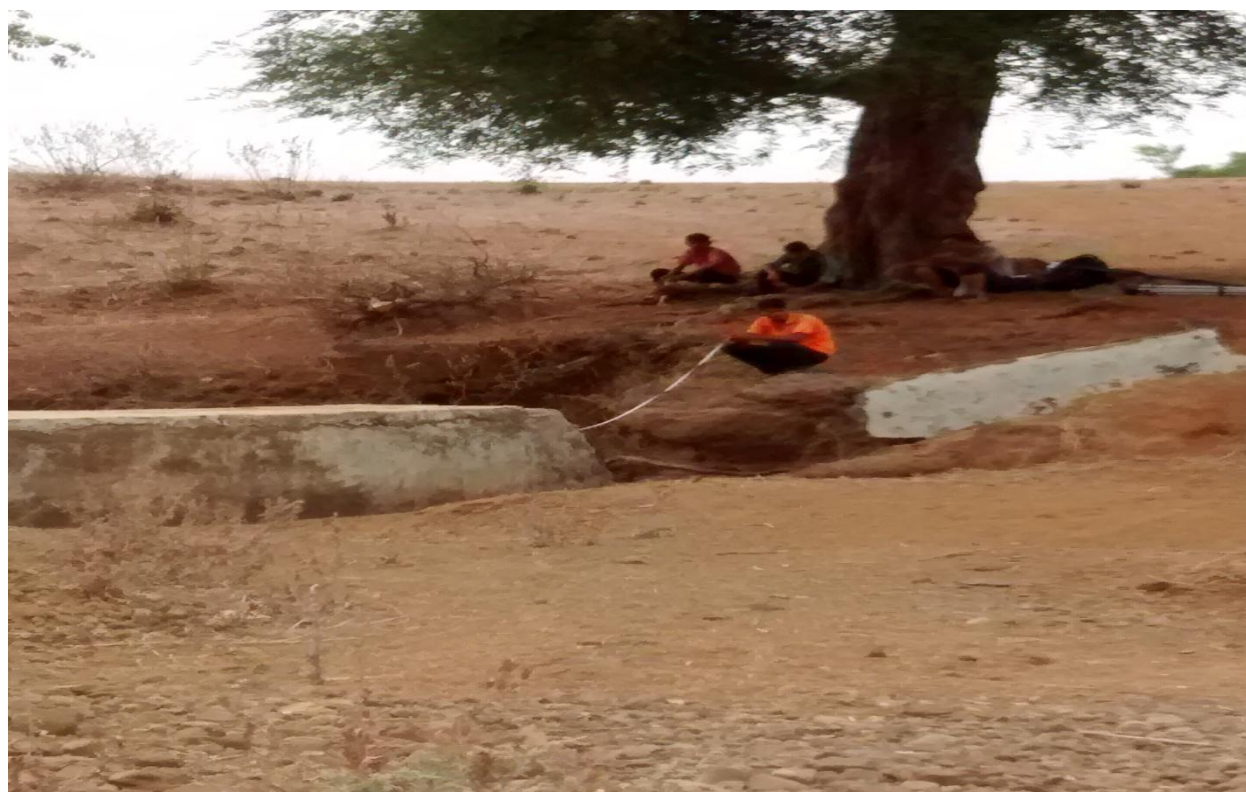
Bhojpada has got another bund which is completely silted and completely broken from middle; repair of this bund is a difficult task. Bund BR1 has got perfect location as majority of agricultural area is nearby to this bund.

Figure 33 Present condition of broken bund (BR1)

**Proposed intervention:** Agricultural area (AA2& AA3) can be irrigated with the help of this bund .DE siltation is needed to increase the storage of water as the area has been completely silted. Repair of this bund is not possible due to complete damage. There is a need of other bund at the same location due to topographical advantages. Siltation is major problem in this region so while designing gate or pipe must be provided at bottom. Latitude and longitude of proposed bund is 19°47'13.49"N and 73°20'19.64"E.
