Watershed Interventions for Kurlod and Botoshi

Phase III

Feb 2017

Technology and Development Solutions Cell (TDSC) Centre for Technology Alternatives for Rural Areas (CTARA) Indian Institute of Technology, Bombay (IITB)

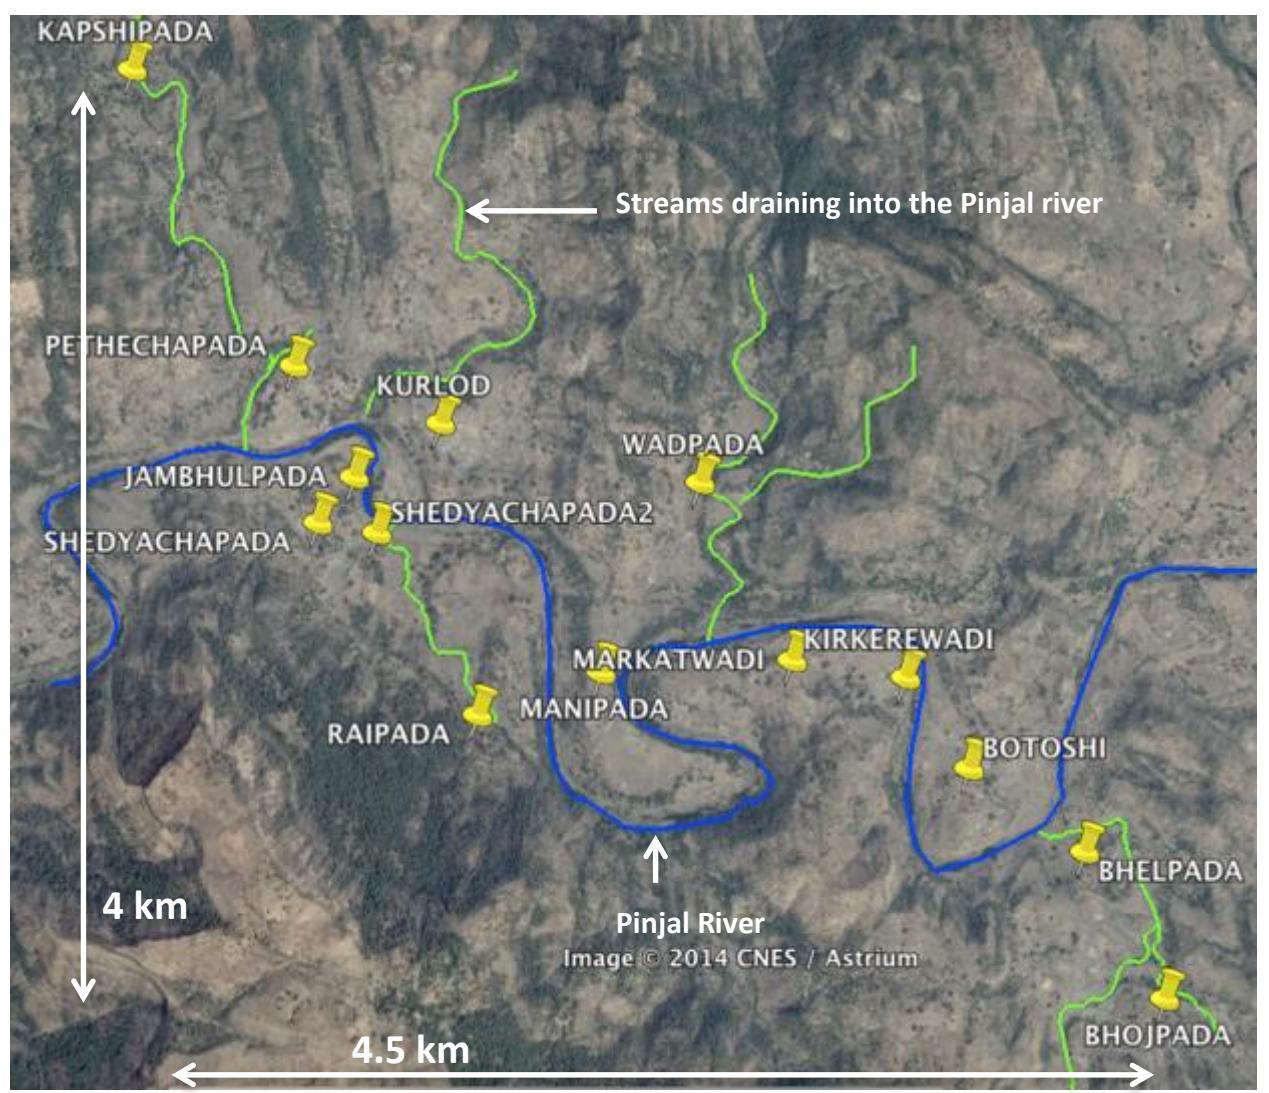
Figure 2 Google Earth image showing layout of habitations in Kurlod and Botoshi.

The habitations are all either close to the Pinjal River, seen in the image below, or by a stream that drains into the river. Neither the streams nor Pinjal are perennial; though these habitations get plenty of rainfall

Pinjal river which is a tributary of Vaitarana, pass through this area and is main water source. Most of habitations of Kurlod and Botoshi are on the banks of this river. There are many streams which join Pinjal as shown in figure 2.

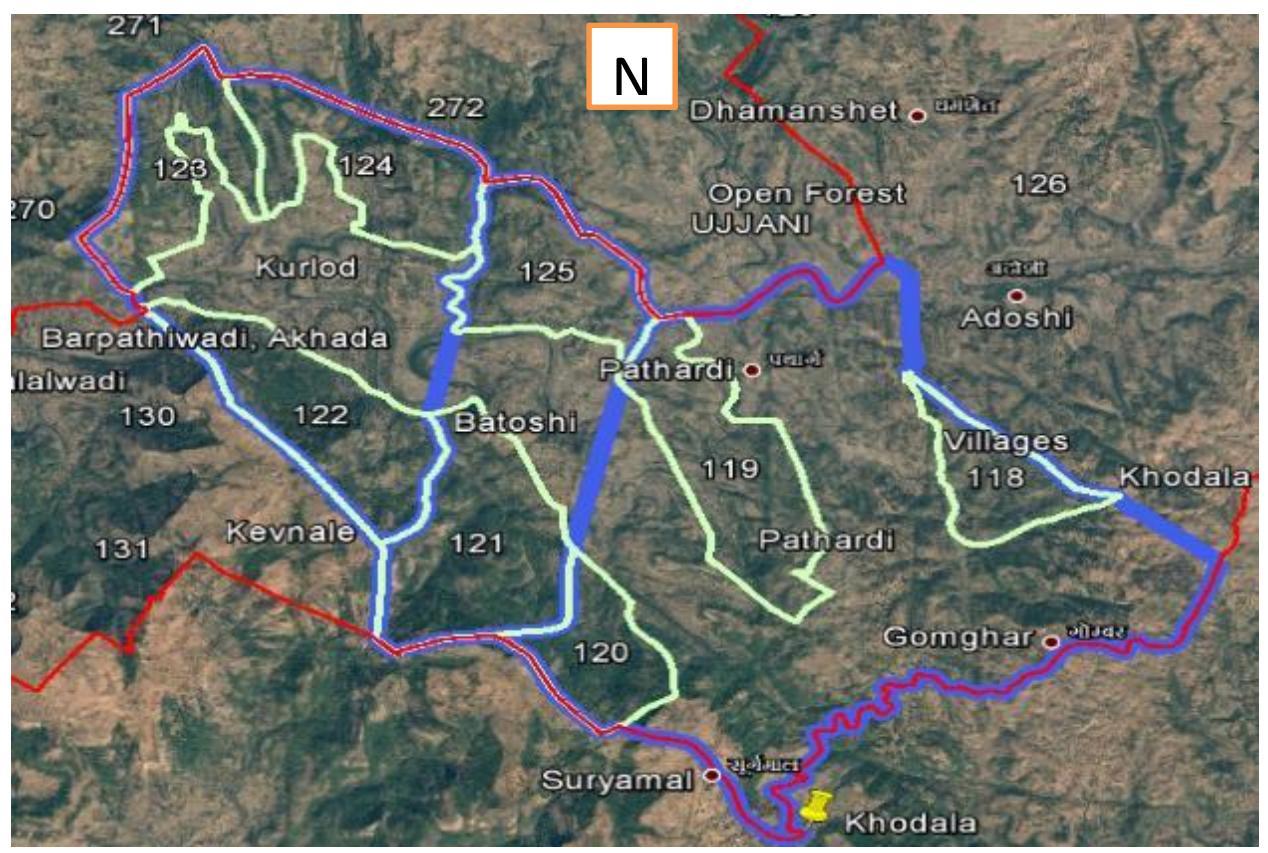
Figure 3 Forest map with three beat of Botoshi, Kurlod and Patherdi

Redline indicates Range boundary, Blue line indicates Beat boundary, yellow line indicates compartment boundary in above figure. Number shown in figure indicates compartment number. Forest area in Kurlod Botoshi are covered under Kurlod beat (Compartment number 122,123,124), Botoshi beat (Compartment number 121,125) and Pathardi beat (Compartment number 118,119,120).

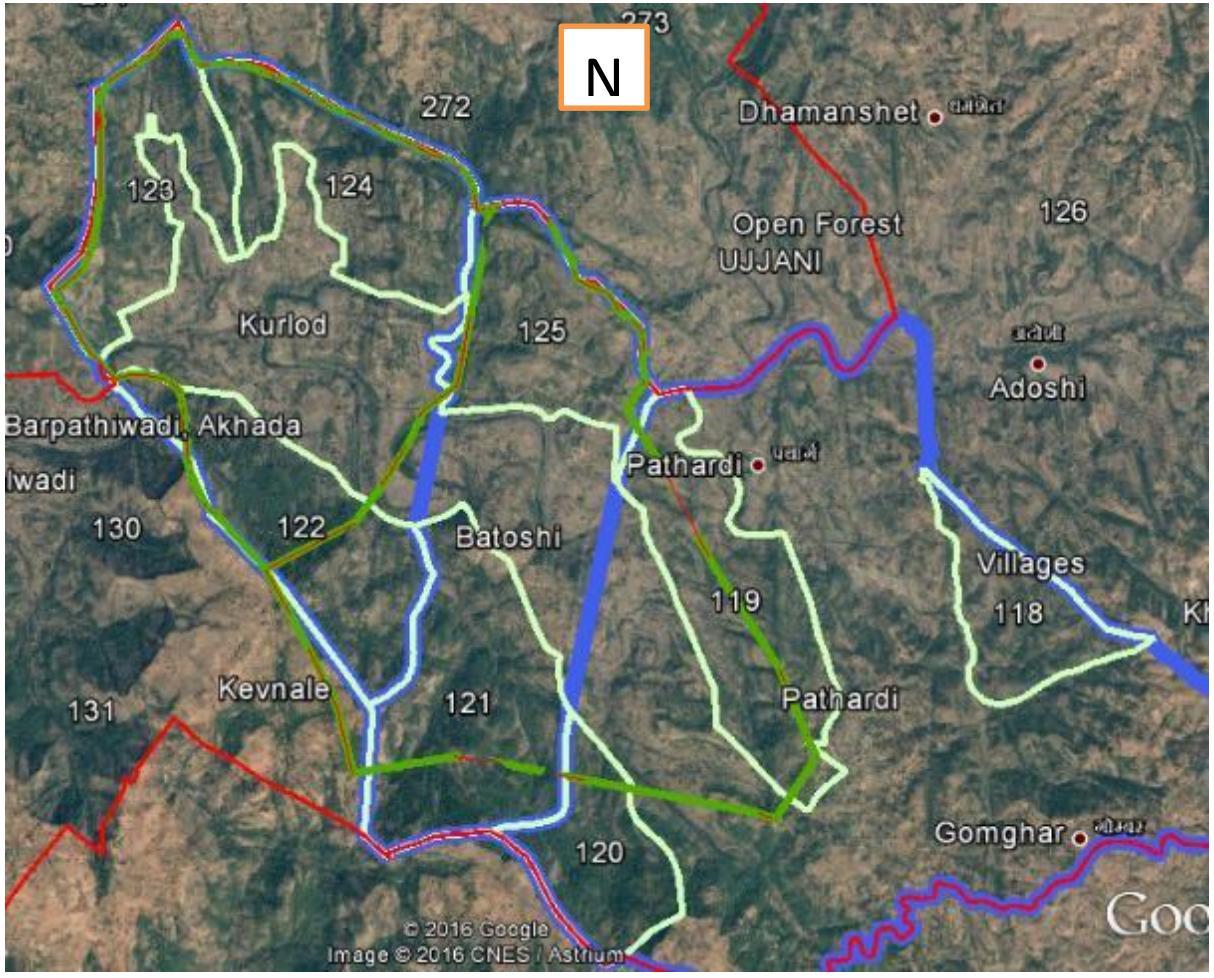
Figure 4 Compartment with Kurlod-Botoshi revenue boundary

Boundary of Kurlod and Botoshi is shown in green colour, light green colour demarcates the compartments.

Since compartment number 118 lies outside of Kurlod Botoshi revenue boundary, it was not considered for planning interventions.

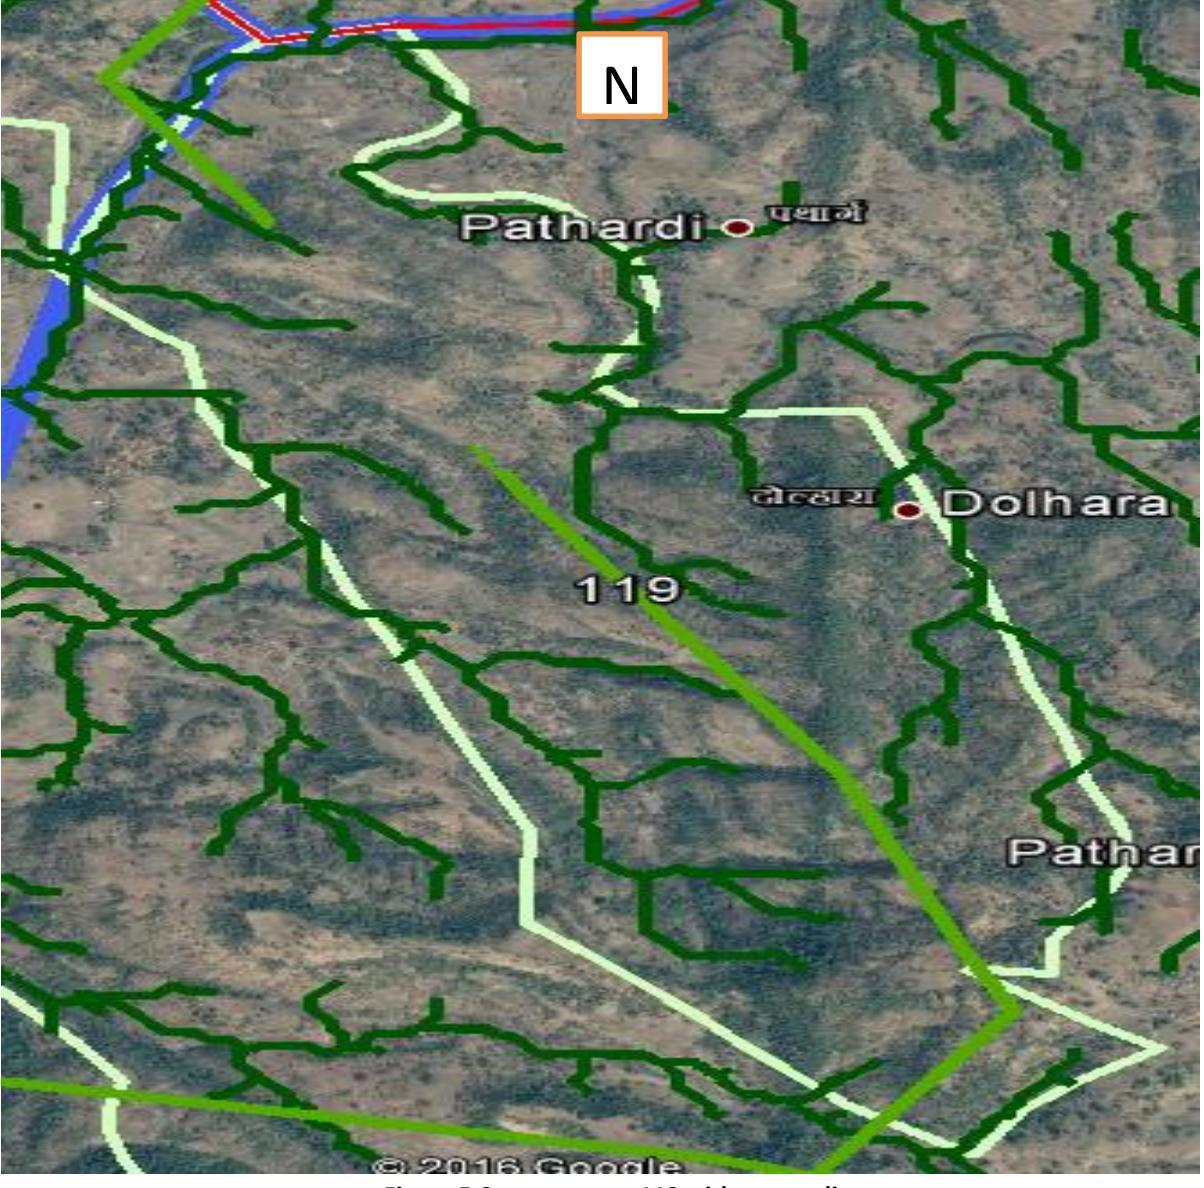
Figure 5 Compartment 119 with stream line

Streamlines are shown in dark green colour, light green colour shows the compartment boundaries and green colour is the village boundary.

Left half of compartment 119 lies in Kurlod-Botoshi boundary. Only first order or second order stream is present in area. Ridge line treatment of gully Plug and contour bund should be constructed at each first and second order stream.

Deforestation assessment: forest left only at ridge line as evident of figure 5.

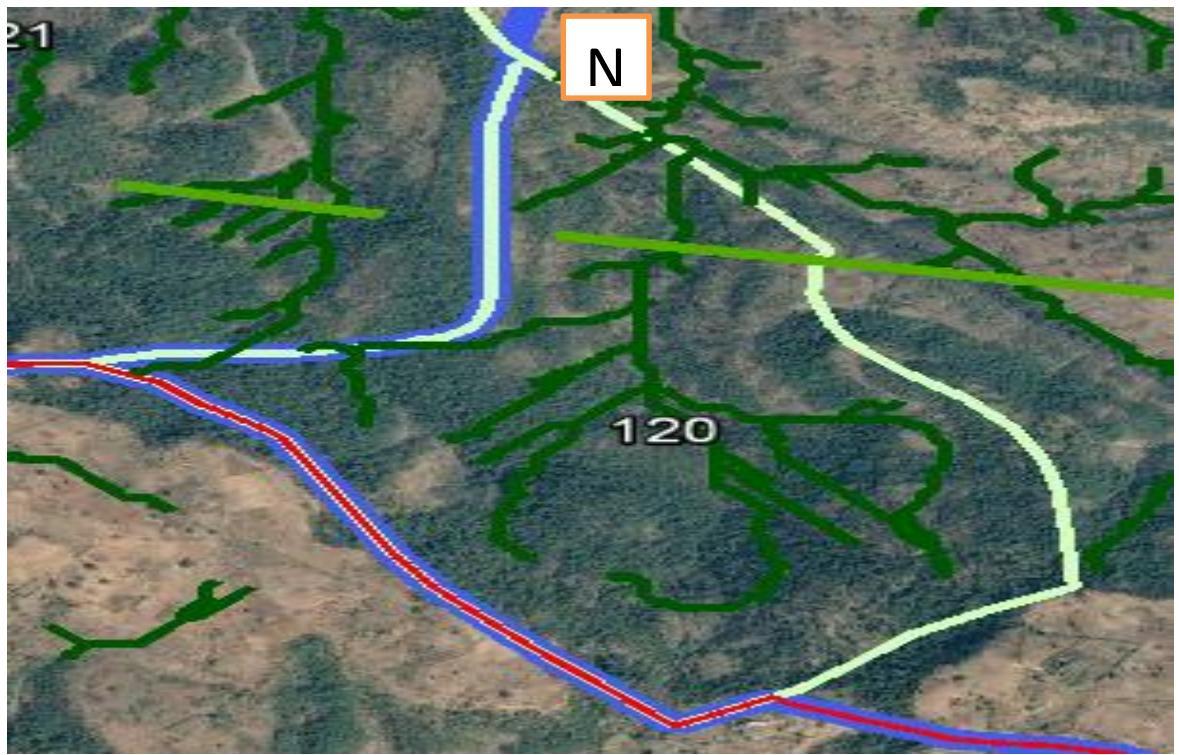
Figure 6 Compartment 120 with stream line

Streamlines are shown in dark green colour, light green colour shows the compartment boundaries and green colour is the village boundary.

Small area of compartment lies in Kurlod-Botoshi boundary. Only first order or second order stream is present in area. Ridge line treatment of gully Plug and contour bund should be constructed at each first and second order stream.

Deforestation assessment: forest cover is good, no reforestation is required

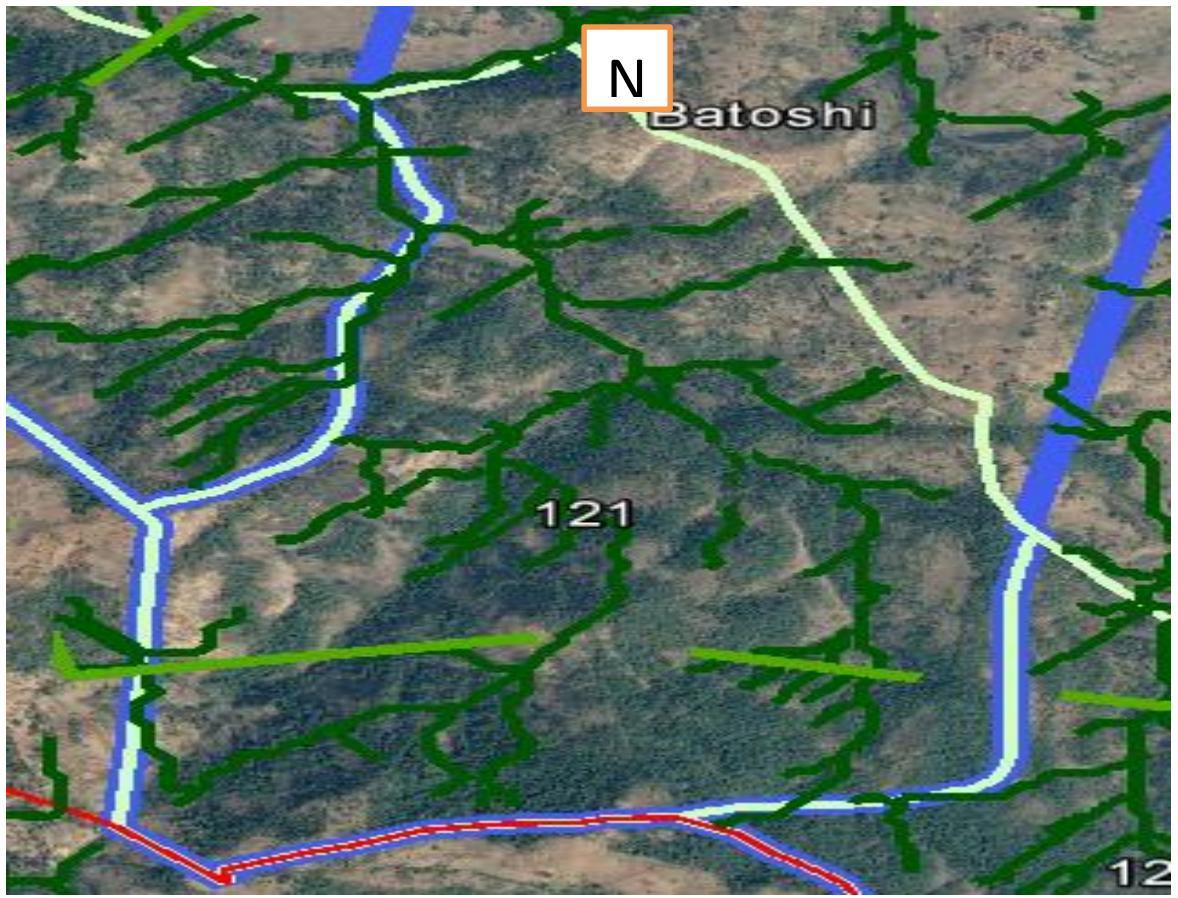
Figure 7 Compartment 121 with stream line

Streamlines are shown in dark green colour, light green colour shows the compartment boundaries and green colour is the village boundary.

large area of compartment lies in Kurlod-Botoshi boundary. Many first order or second order streams present in area. Ridge line treatment of gully Plug and contour bund should be constructed at each first and second order stream. One major stream meets pinjal in manipada. Intervention on that stream are covered in stream line intervention.

Deforestation: Forest cover is good in upper part of compartment but degraded forest is present near rivers. Forest department has also allotted patta of land to villagers of Korlod Botoshi in this compartment.

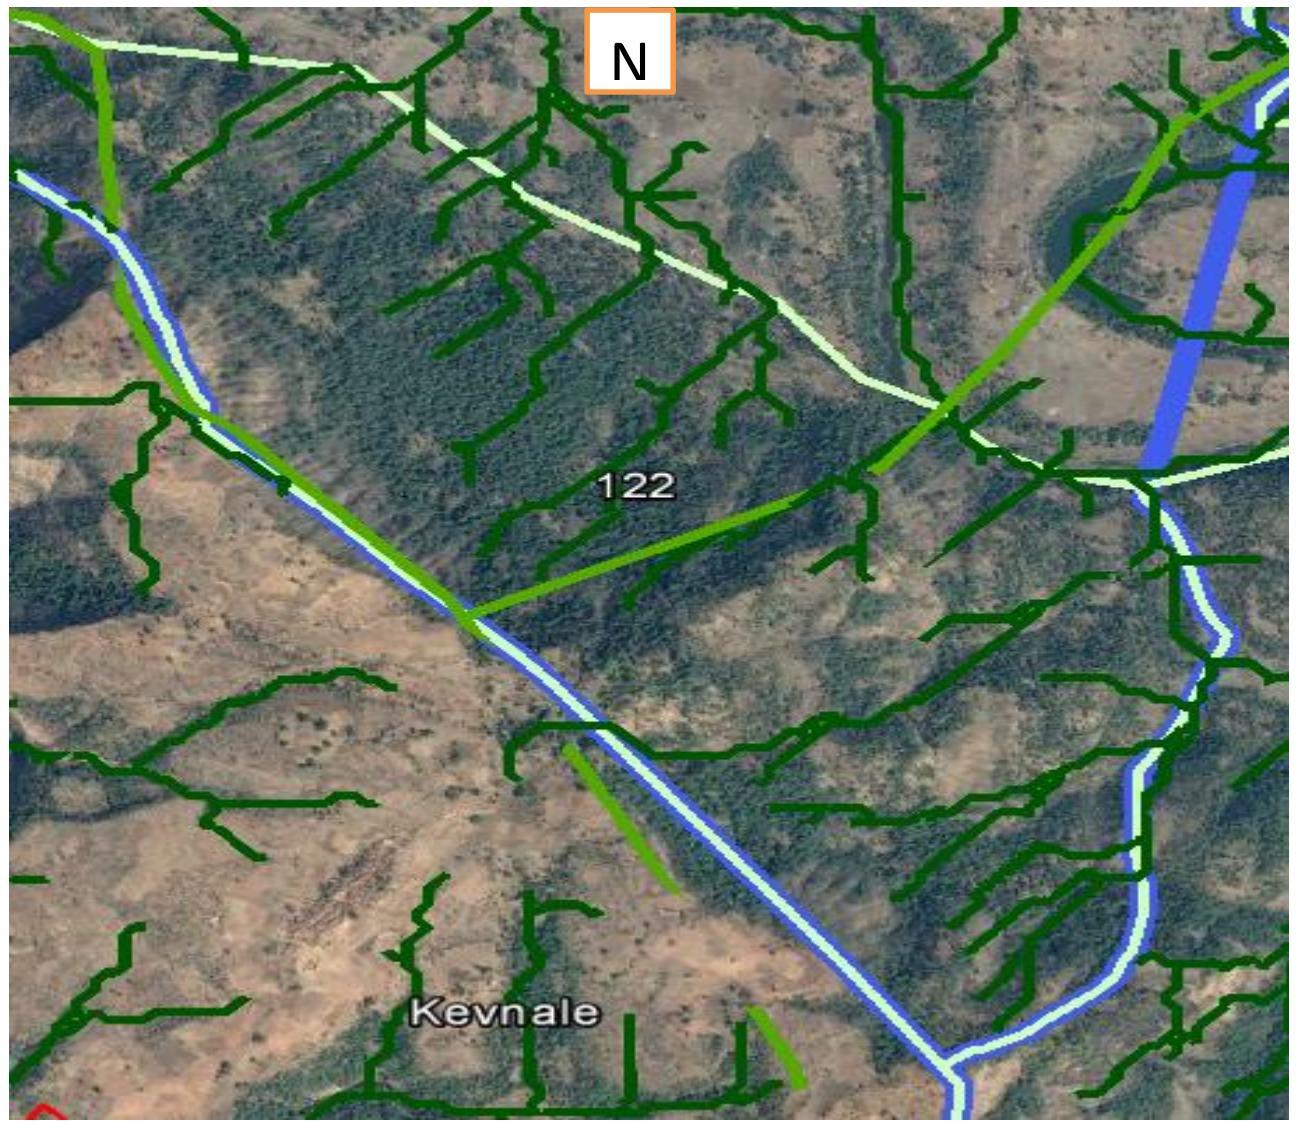
Figure 8 Compartment 122 with stream line

Streamlines are shown in dark green colour, light green colour shows the compartment boundaries and green colour is the village boundary.

All area of compartment lies in Kurlod-Botoshi boundary. Many first order or second order streams present in area. Ridge line treatment of gully Plug and contour bund should be done at these streams. No major stream is present here. Raipada- shedyapada stream originates from this compartment.

Deforestation assessment: forest good in most parts, no reforestation required.

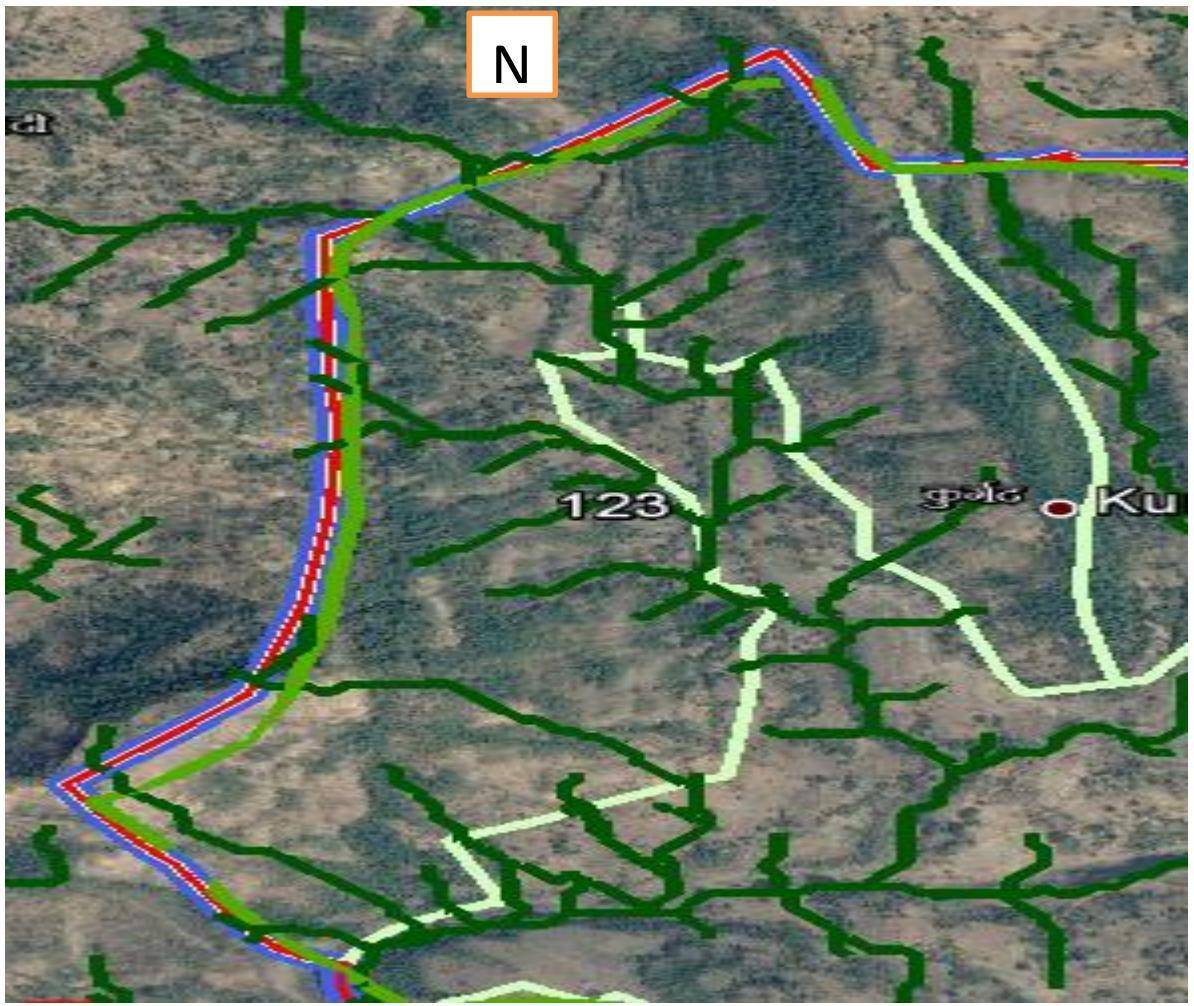
Figure 9 Compartment 123 with stream line

Streamlines are shown in dark green colour, light green colour shows the compartment boundaries and green colour is the village boundary.

All area of compartment lies in Kurlod-Botoshi boundary. Many first order or second order streams are present in area. Ridge line treatment of gully Plug and contour bund should be constructed at each first and second order stream.

Deforestation assessment: very high only little forest left at ridge, Reforestation is required

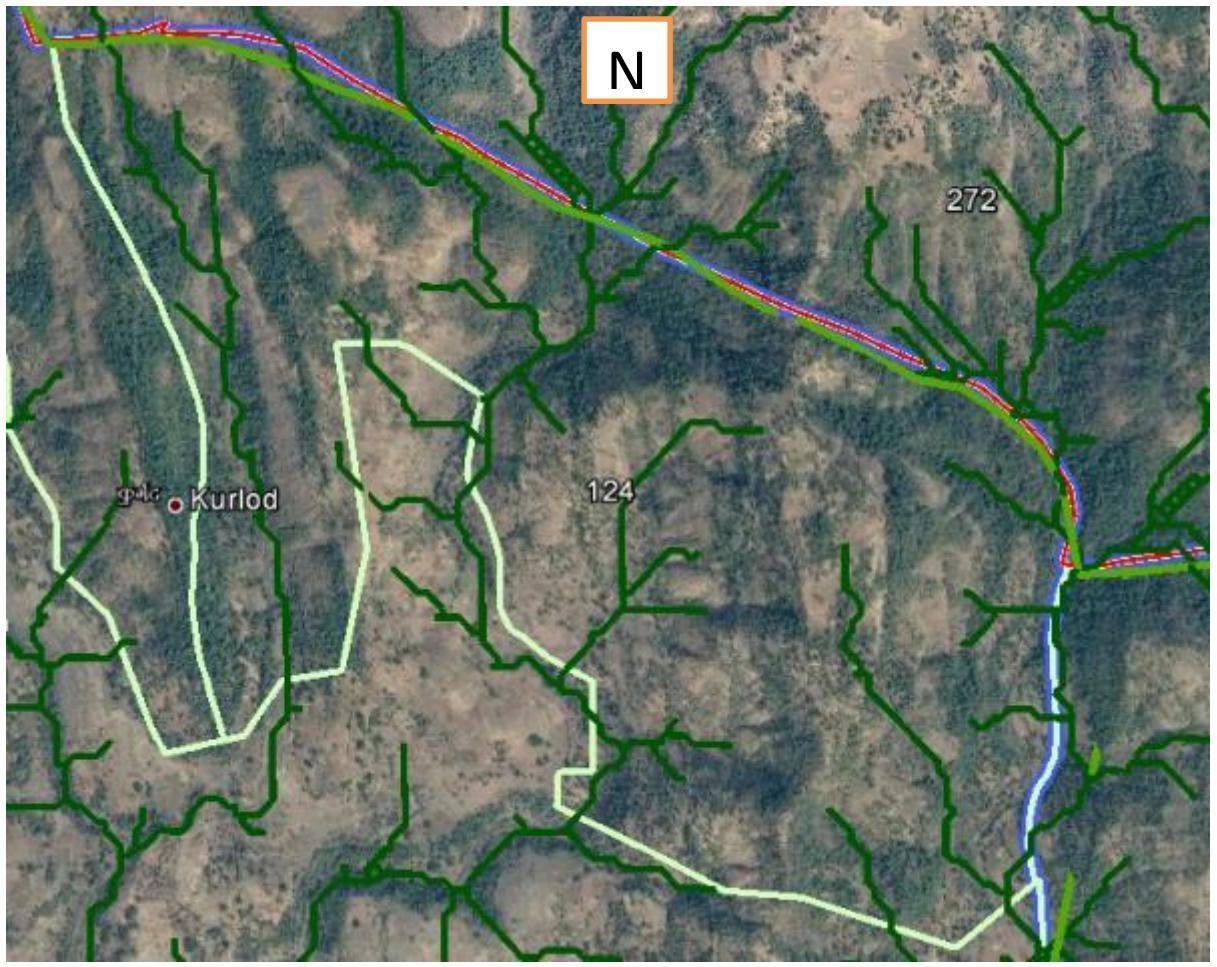
Figure 10 Compartment 124 with stream line

Streamlines are shown in dark green colour, light green colour shows the compartment boundaries and green colour is the village boundary.

All area of compartment lies in Kurlod-Botoshi boundary. It is the biggest compartment in Kurlod-Botoshi.

Deforestation assessment: Deforestation is very high, only little forest left at ridge. Reforestation in required in this compartment.

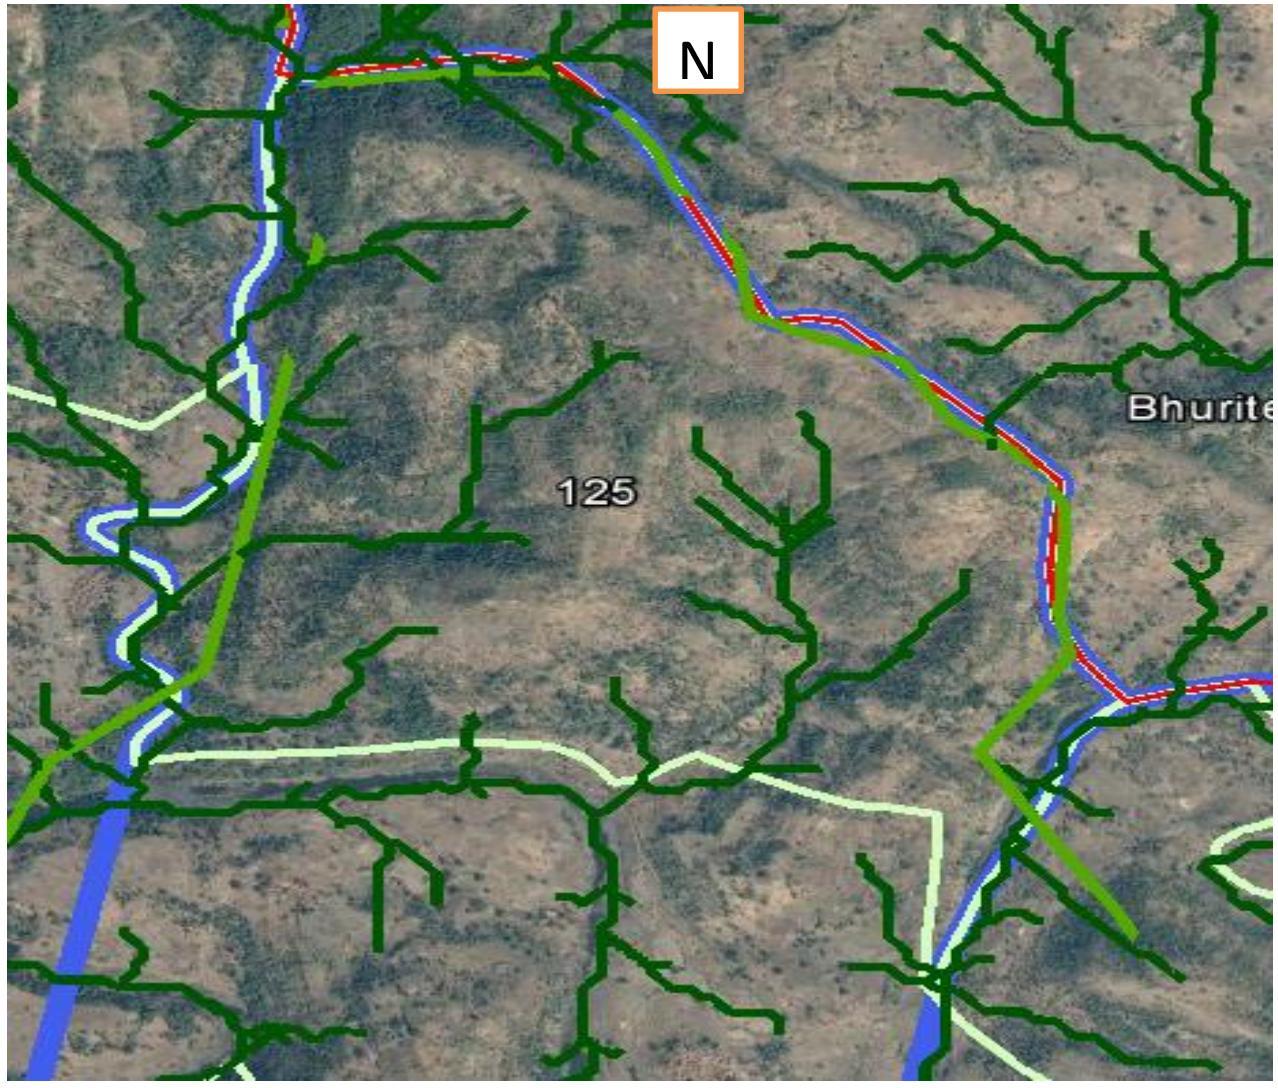
Figure 11 Compartment 125 with stream line

Streamlines are shown in dark green colour, light green colour shows the compartment boundaries and green colour is the village boundary.

Deforestation assessment : Deforestation is very high, only little forest left at ridge. Reforestation in required in this compartment.
